A GUIDE TO SECOND WORLD WAR ARCHAEOLOGY IN SUFFOLK

Guide 2: Walberswick to Aldeburgh

Robert Liddiard and David Sims

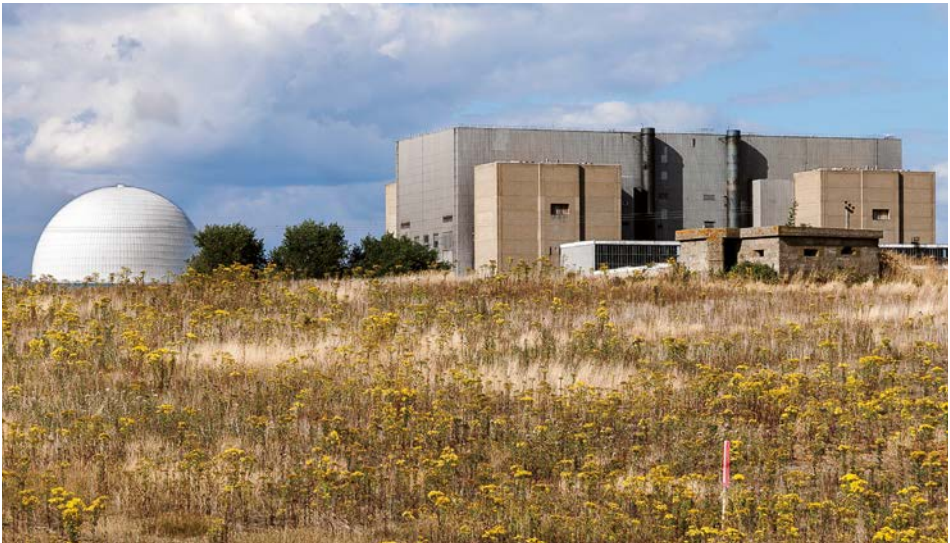
Suffolk Square pillbox against the backdrop of Sizewell power station.

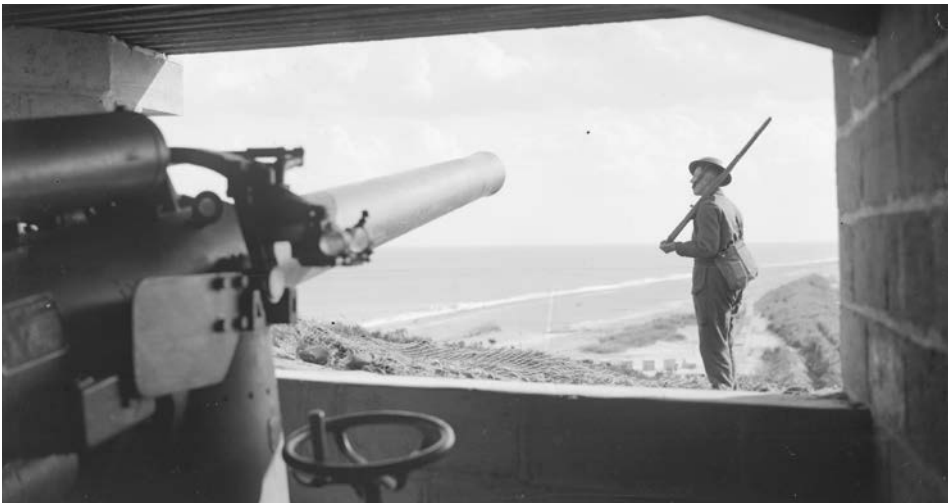
Figure 1. A posed wartime photograph taken from one of the gun houses at Minsmere Emergency Coastal Defence Battery, 1941. Today, the area is used for recreation and the management of biodiversity, but during the war was very much on the front line. (Imperial War Museum H 4335)

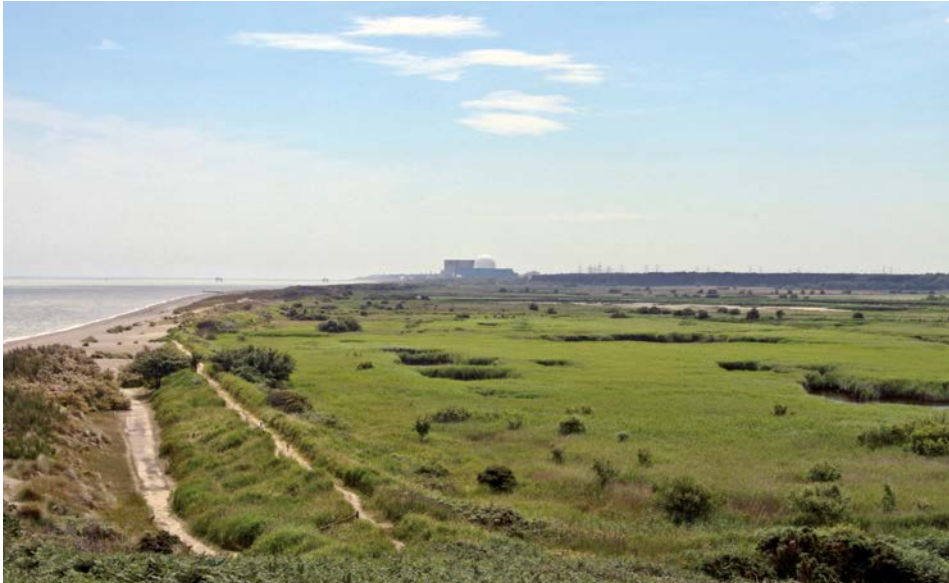
Figure 3. View from Dunwich, one of the 'spurs' identified by the military as key to the defence of the area during the Second World War. The view is to the south and shows another spur – Sizewell – separated from Dunwich by the Minsmere levels. In 1940 the fear was that German armoured columns would use such spurs to move inland before advancing on London.

Certain well-defined spurs [Aldeburgh, Thorpness, Sizewell, Dunwich and Walberswick] along which run the main approaches inland and are divided from one another by marshy areas [and cliffs] where the streams run into the sea. This formation will necessitate the capture of the spurs by an invader before ingress inland on a large scale can be made. It therefore lends itself to defence by strong locations on the spurs, the intervening marshes being made as impassable as possible. (Figures 3 and 4)

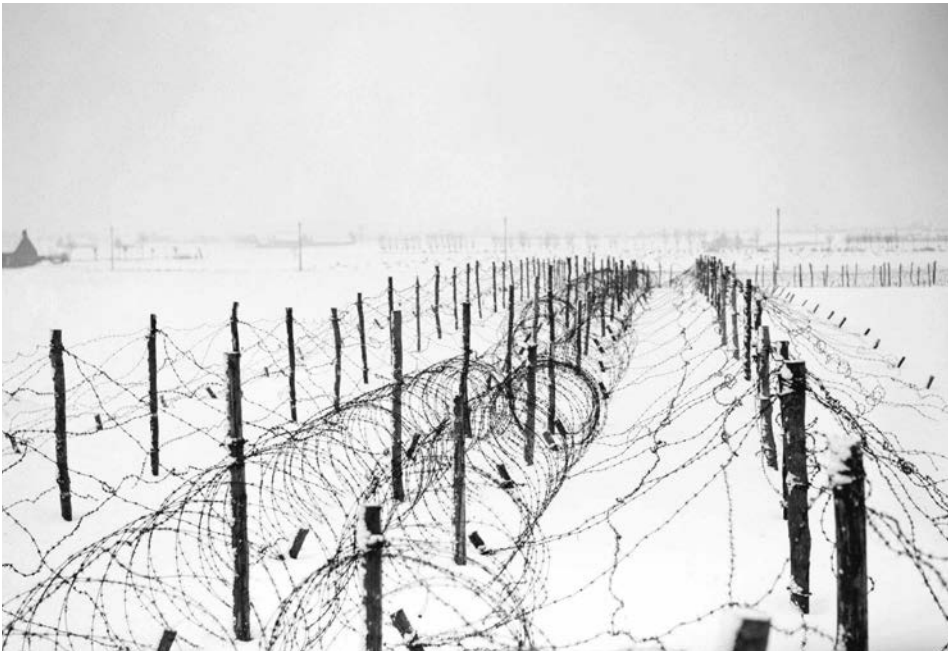
Figure 6. Barbed wire in northern France in the winter of 1939-40. Wire of this kind was placed on Suffolk's beaches as soon as the invasion crisis of 1940 began. (Imperial War Museum O 0878)

On the beaches one of the easiest methods of slowing up an invader was to cover the ground with barbed wire. Wire was one of the few commodities in relatively plentiful supply in 1940 and could easily turn an open beach into an altogether more daunting prospect to negotiate. The placing of wire was carried out with care. Long lines were usually positioned parallel to the sea just above high water mark, with entanglements at right angles to create bottlenecks. The impression given by aerial photography is that, by the end of the summer, almost the whole coastline across the study area was heavily wired (Figure 6).

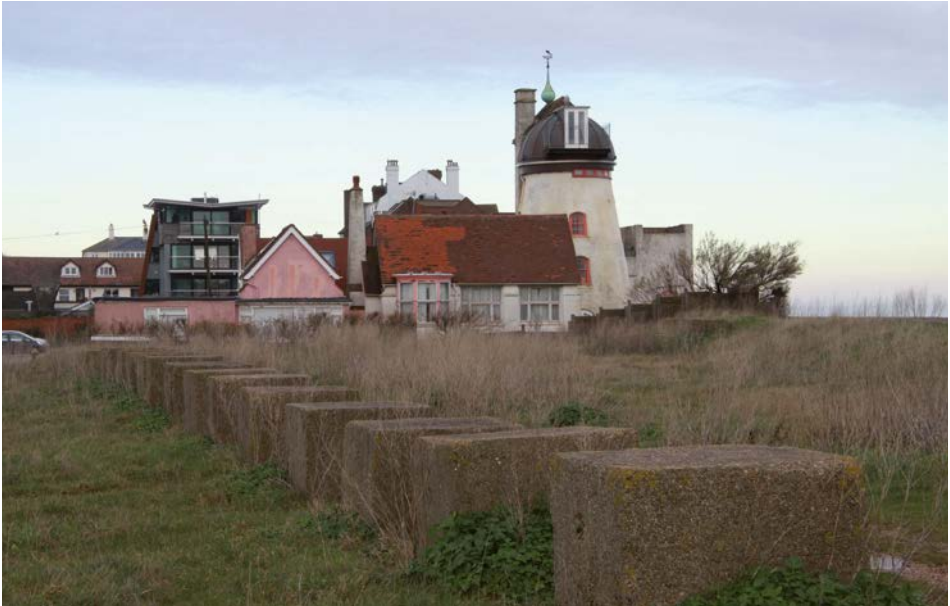
Figure 7. Anti-tank blocks at Aldeburgh. They originally formed an obstacle running from the Emergency Coastal Defence Battery to the marshes to the south of the town.

Anti-tank blocks were used in two main ways. First, short lengths provided a barrier across a specific area and were integrated with other anti-invasion defences. Short lines could also be placed at right angles to the sea in order to stop movement up and down the long beaches typical of this part of the Suffolk coastline. Second, more extensive use provided protection in places where the topography left large natural gaps. At Aldeburgh, the area to the south of the town was given a row of blocks that created an obstacle between the Emergency Coastal Battery and the Martello tower, while at Minsmere several hundred metres of cubes were laid on the beach (Figure 7).

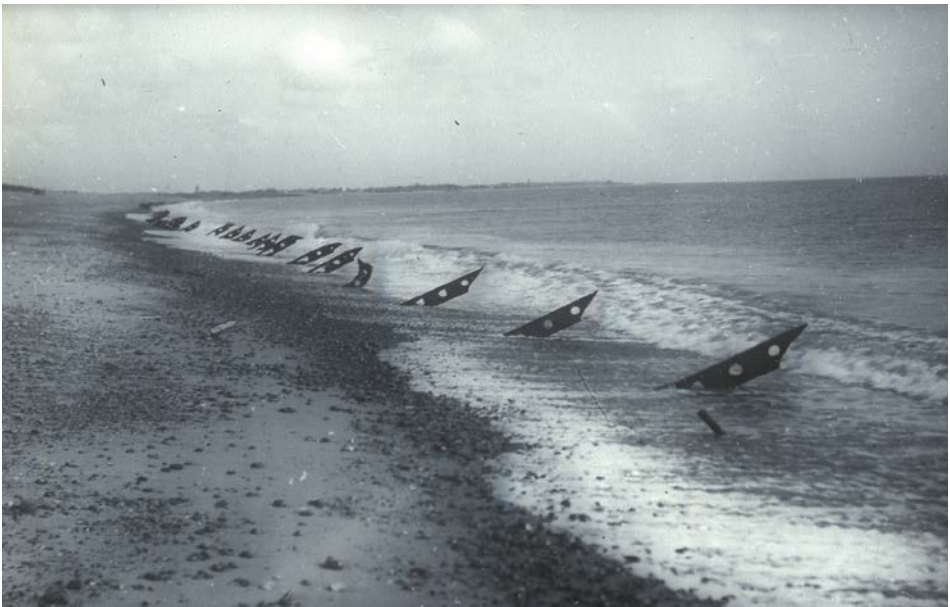
Figure 8. Photo c.1946 of Dunwich beach, showing it largely devoid of the wartime defences but with Dragon's Teeth still intact. (Courtesy of Dunwich Museum)

The final part of the beach defences were ‘Dragon’s Teeth’, which comprised sharpened steel spike set in concrete and placed in lines in the inter-tidal zone. Their purpose was to rip the bottom out of landing barges as they attempted to beach. A series of teeth was laid along the coast; but all have since been removed, but their rather sinister appearance is still apparent from post-war photographs (Figure 8).

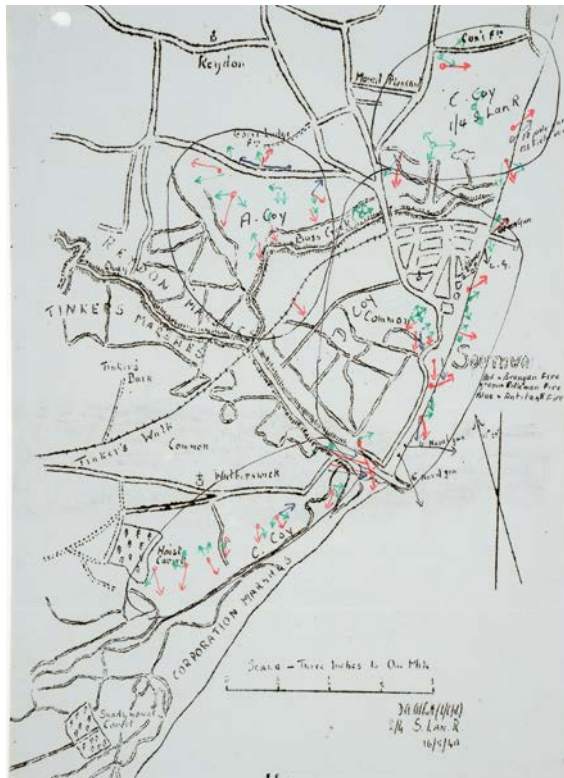
Figure 9. Map from the 2nd/4th South Lancashire Regiment showing dispositions in August 1940. The position of each infantry section of ten men is shown, along with their arcs of fire. (The National Archives)

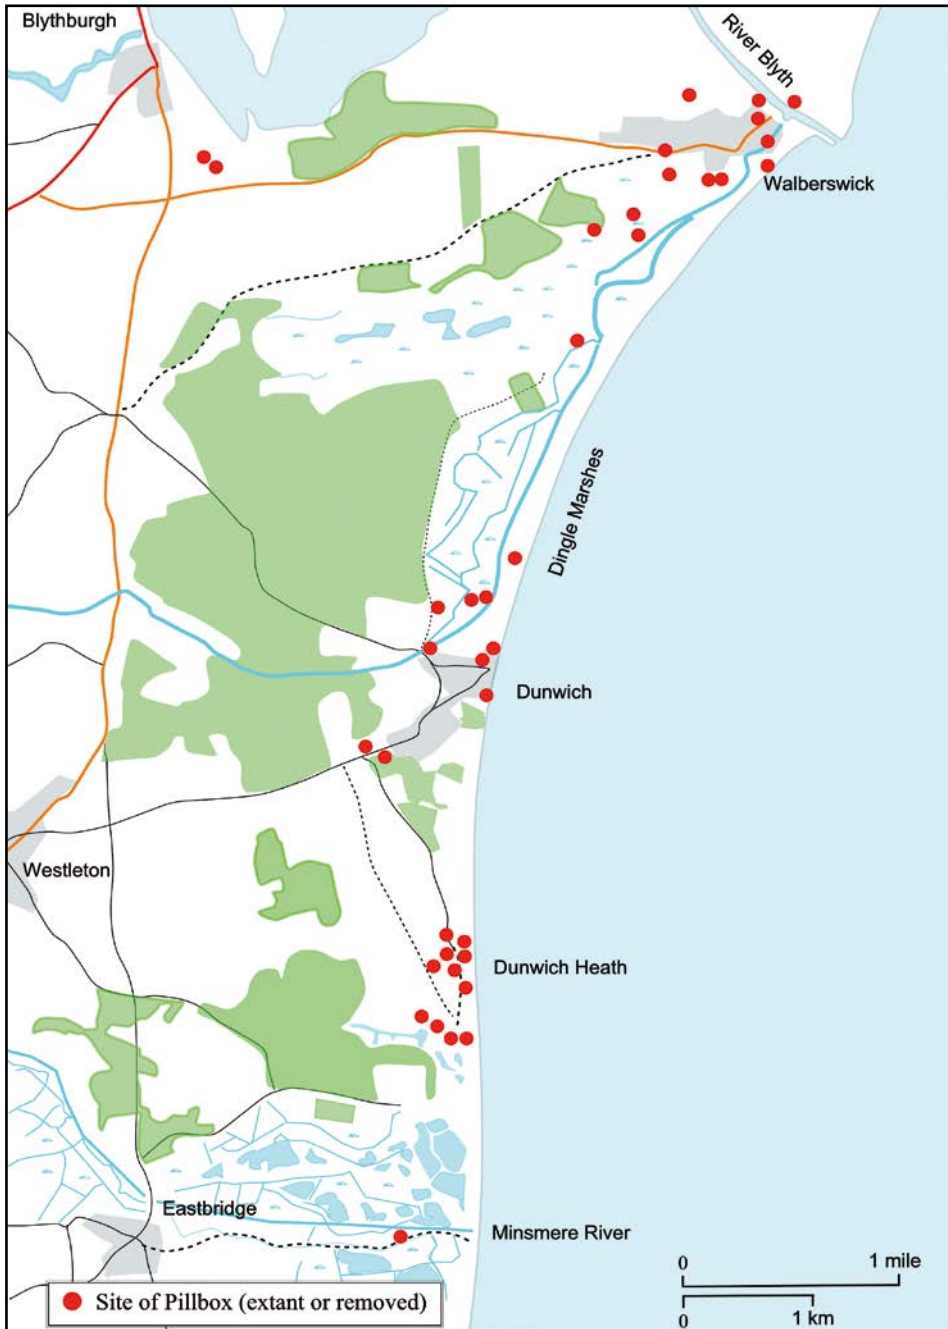
Figure 10. Map of pillbox distribution in the study area. The clustering on the beaches at the end of the 'spurs' can clearly be seen, with only a scatter inland from the coastline itself.

Today, a rough guide to the location of many former positions is the existence of concrete pillboxes, the vast majority of which were built during the summer of 1940 (Figure 10). In the area covered by this

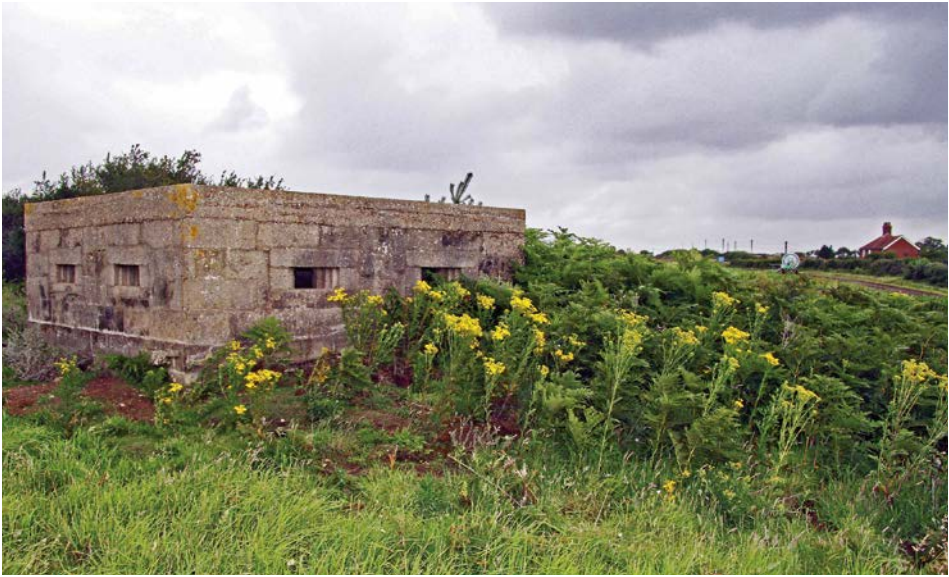
Figure 11. Typical ‘Suffolk Square’ pillbox at Knodishall, inland from Aldeburgh.

guide nearly all the pillboxes are of a particular type, known to modern observers as the ‘Suffolk Square’ – owing to their distinctive shape and the fact they are found only in Suffolk. (Figure 11) Their restricted distribution and idiosyncratic appearance are almost certainly results of the fact they were built by one particular unit – 558 Field Company, Royal Engineers – who were attached to 55 Division during 1940 and were based at Theberton Hall, near Saxmundham. The pillboxes were either built directly by the engineers themselves or by contractors working under military supervision.

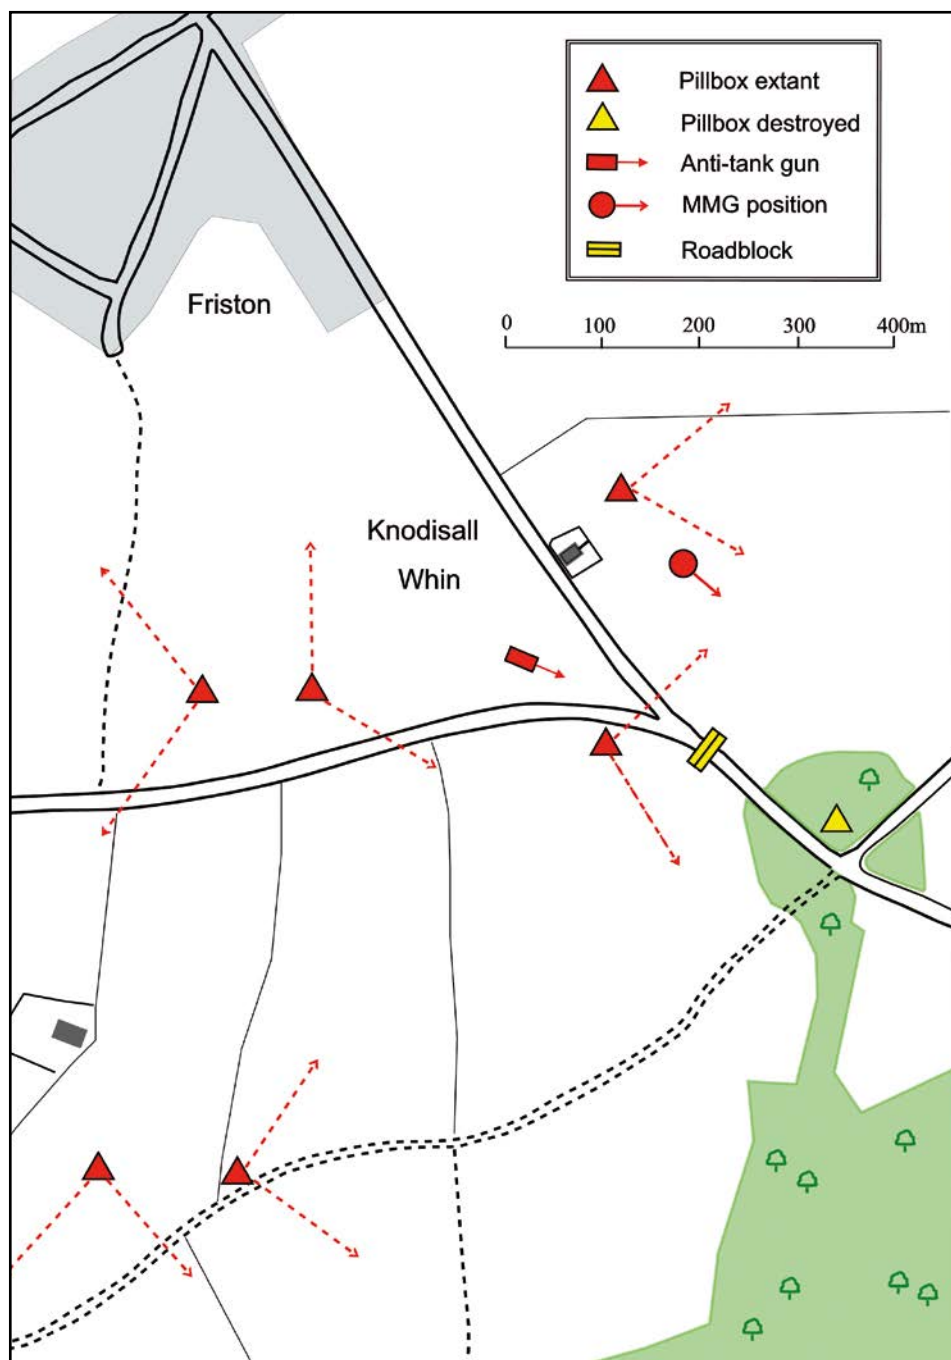
Figure 12. Knodishall Whin. The group of pillboxes in this area were part of a company-strong (about 120 men) defensive position in the area inland from Aldeburgh.

from Aldeburgh, a surviving group of pillboxes marks the location where a reserve company of the 9th King's Regiment was intended to slow down the advance of an enemy column inland after it had broken through from the beach (Figure 12). At Walberswick a pair of strengthened pillboxes for heavy machine guns was sited some four kilometres back from the beach in order to allow heavy fire to be put down both on the road along the 'spur' and along the valley of the Blyth itself (Figure 13)

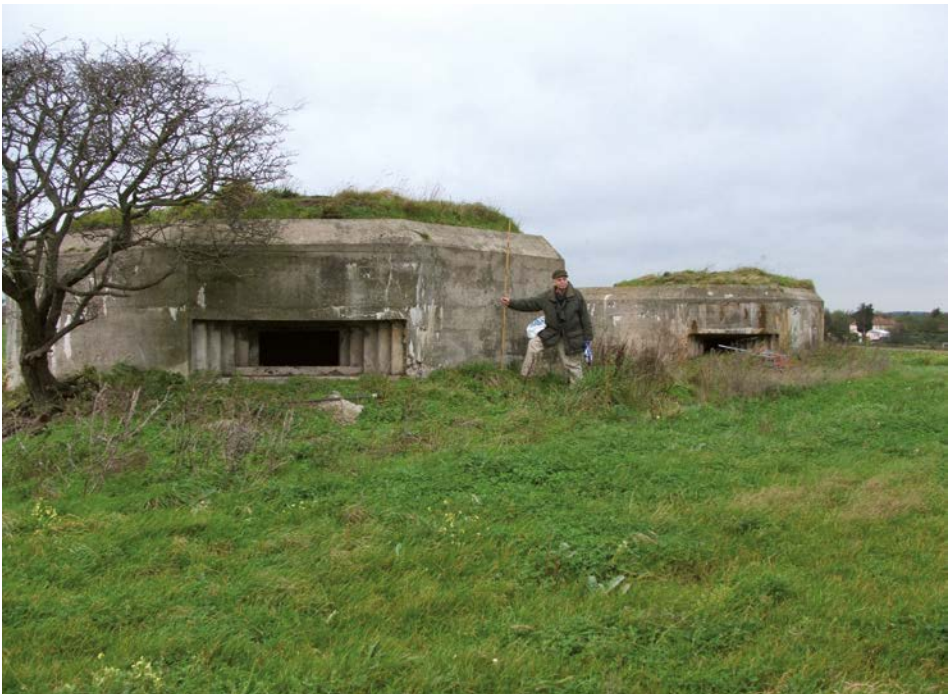
Figure 13. Heavy machine gun pillboxes at Blythborough. These positions represented the final element of the 'coastal crust' and were intended to block the path of enemy forces moving inland along the road from Walberswick or attempting to navigate up the river Blyth.

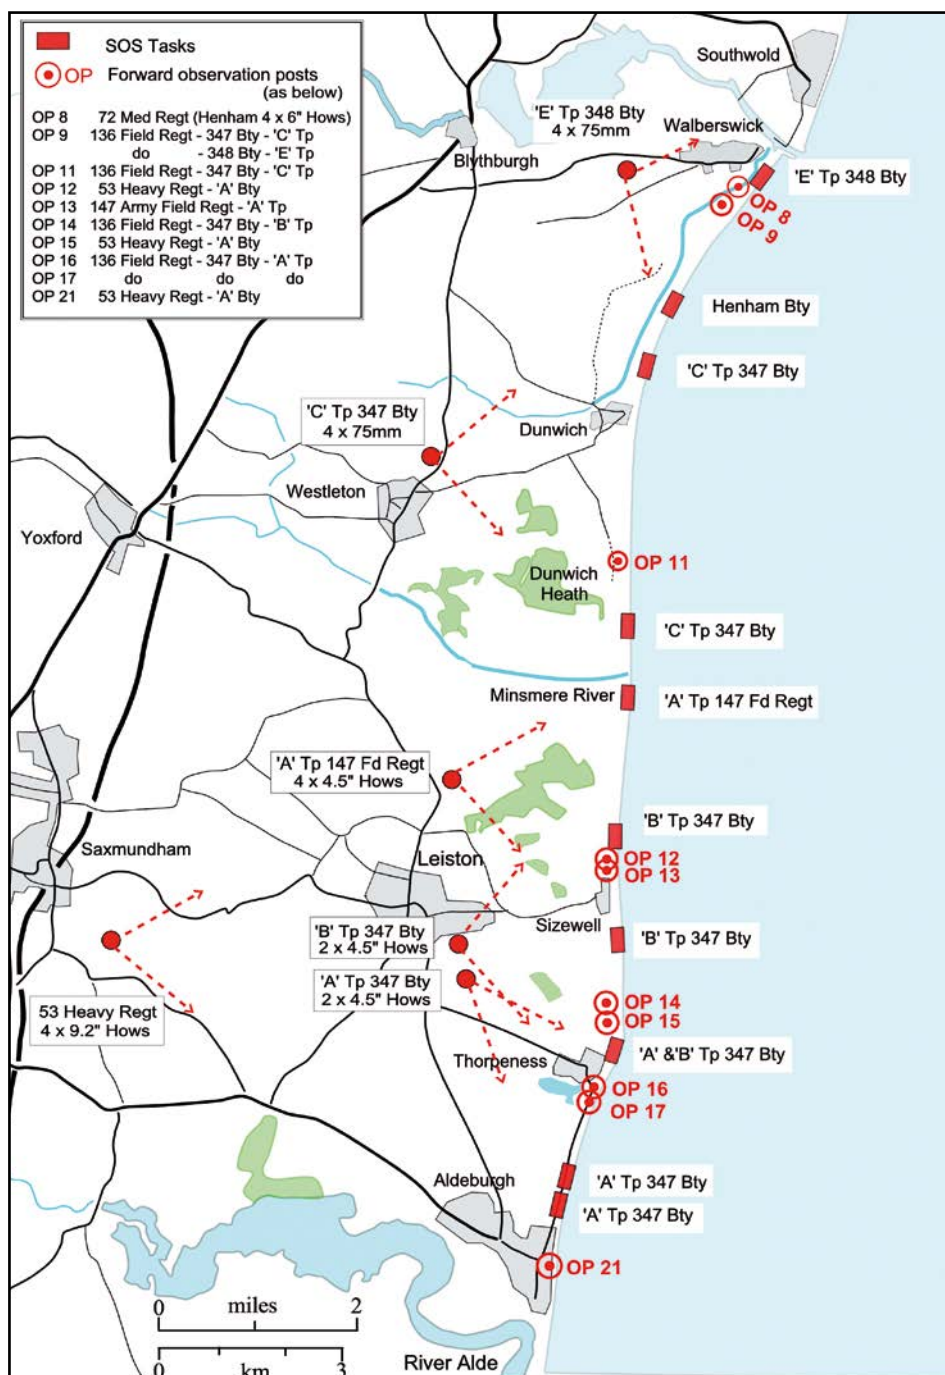
Figure 14. Artillery fireplan from 1940 showing location of guns, arcs of fire, observation posts and designated SOS tasks.

The location of the guns was arranged so that, in principle, all parts of the coastline could be covered by artillery fire; places thought especially vulnerable could be subjected to a bombardment by a multiplicity of guns firing from several locations at the same time. The particularly vital points that were critical to the defence were designated ‘SOS’ tasks, which were pre-arranged targets that the gunners could immediately fire upon in the event of receipt of a message from the observers or in the form of a rocket signal fired by the defending troops. Seven such tasks existed between the Blyth and the Alde and most were probable disembarkation points on the beaches or bottlenecks where invading troops would be constrained by topography (Figure 14).

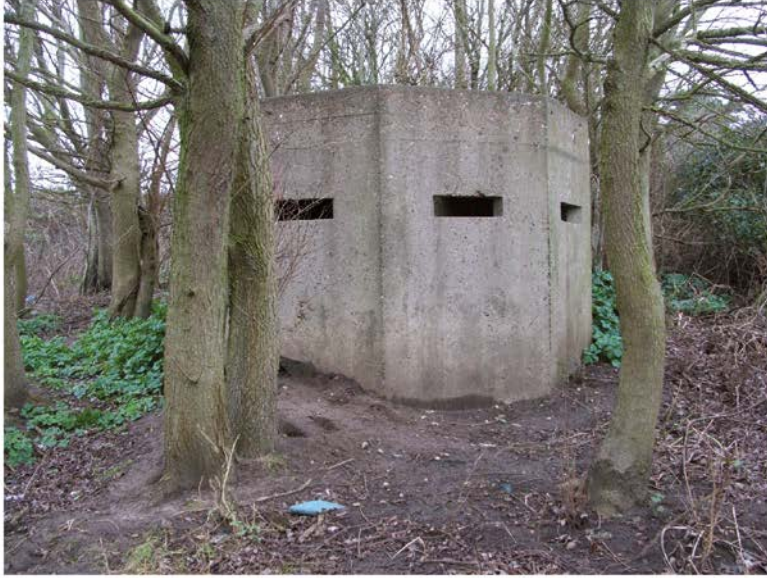
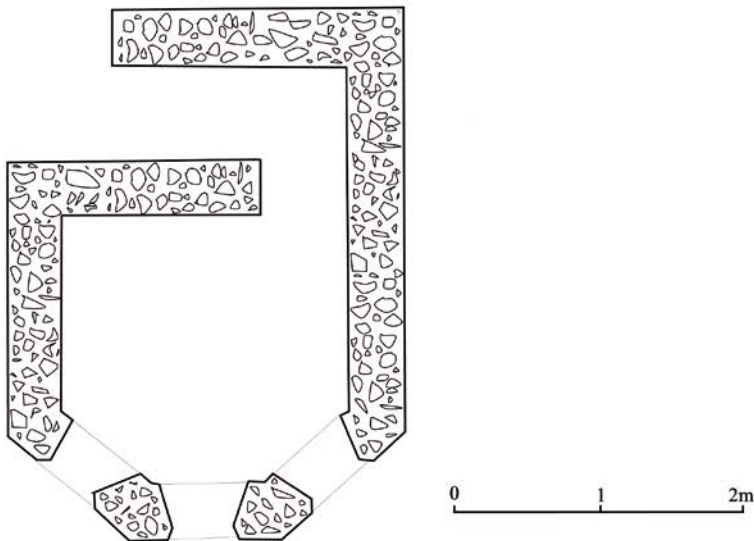
Figure 15. Artillery Observation Post at Walberswick. Although resembling an infantry pill-box, these structures were for artillerymen spotting for their guns further behind the lines.

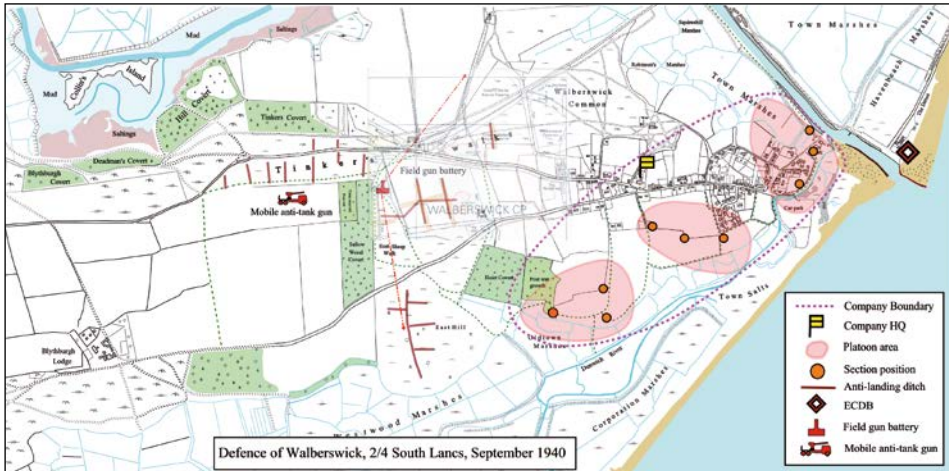
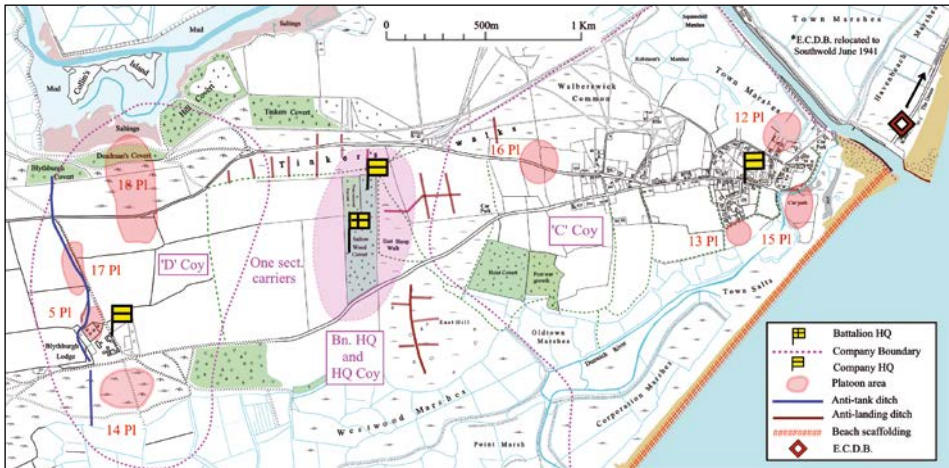
Figures 16 and 17. The changing defence landscape at Walberswick. Here the linear system of defence put in place in 1940 changed to a system of defence in depth the following year, with 'Forward Defended Localities'.

In accordance with these instructions, 125 Brigade set about implementing the new defensive scheme. While some of the areas chosen for the new localities were already fortified and the existing defences were simply adapted, in other places, whole sections of the 1940 line were abandoned and fresh positions created. A very clear example of the new defence scheme can be seen at Walberswick, where defence in depth along the

'spur' running inland replaced the earlier arrangement (Figures 16 and 17). In those places where the 1940 positions could be incorporated into the new scheme pillboxes were retained, but where new trenches were dug they lacked concrete defences and were simply earthworks. (Figures 18 and 19).

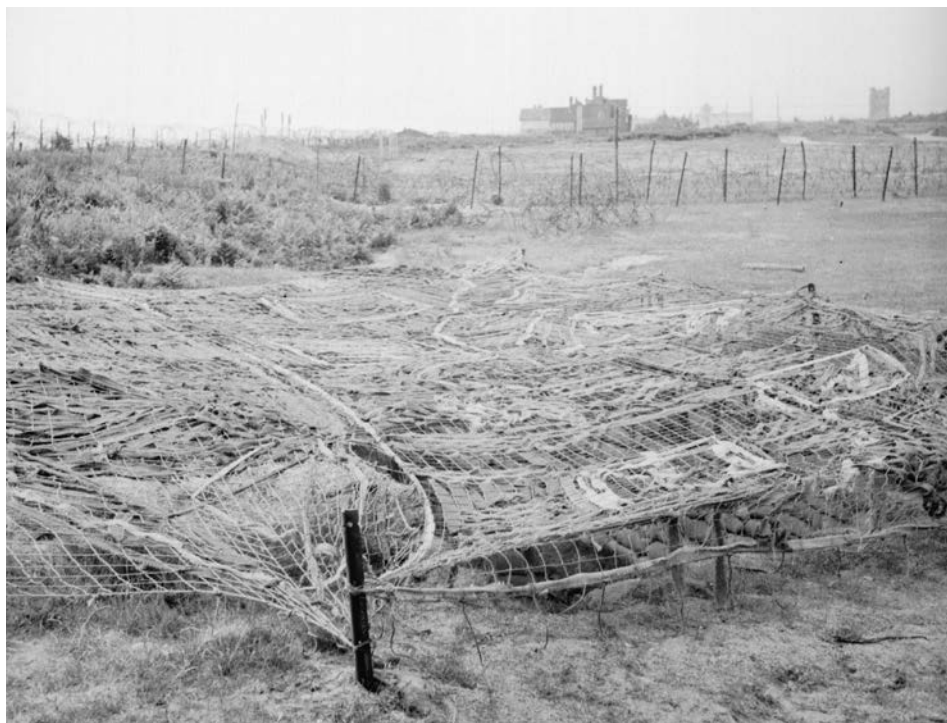
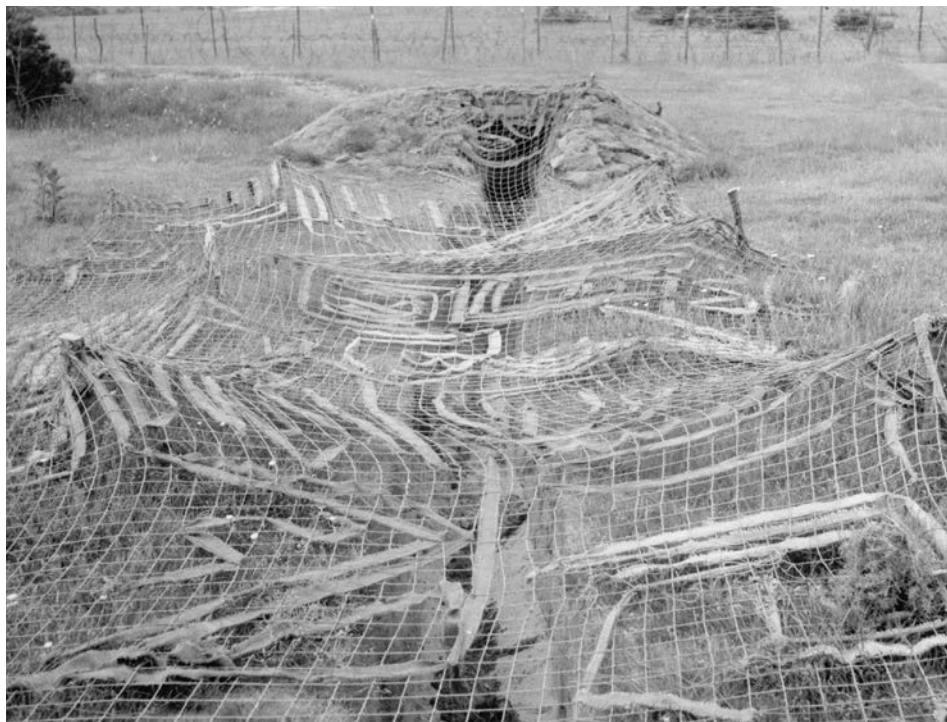
Figures 18 and 19. Wartime photographs showing camouflaged trench positions near Thorpeness in 1941. (IWM H11461; H11462)

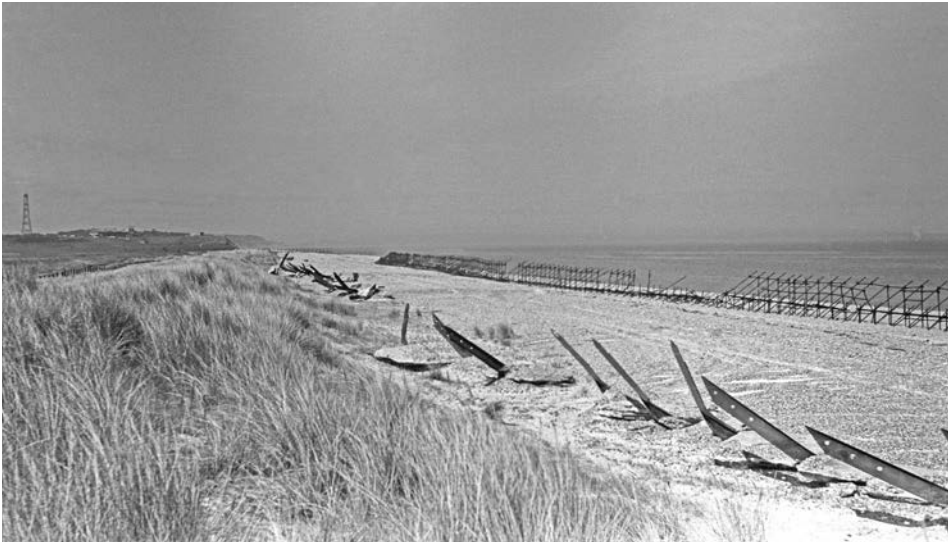
Figure 20. The coastline at Minsmere soon after the war. The dragon's teeth have been removed and are awaiting collection, while the beach scaffolding remains. (Eric Hosking Trust)

The creation of the forward defended localities took place alongside the construction of additional defences, some of which have left a considerable mark on the landscape. Perhaps the greatest visual change to the beach defences in 1941 was the appearance of beach scaffolding: a linear framework of metal poles that stood three metres high. As a barrier scaffolding was simple and effective; it was difficult to destroy with tank fire and challenging for armoured vehicles to cross (Figure 20).

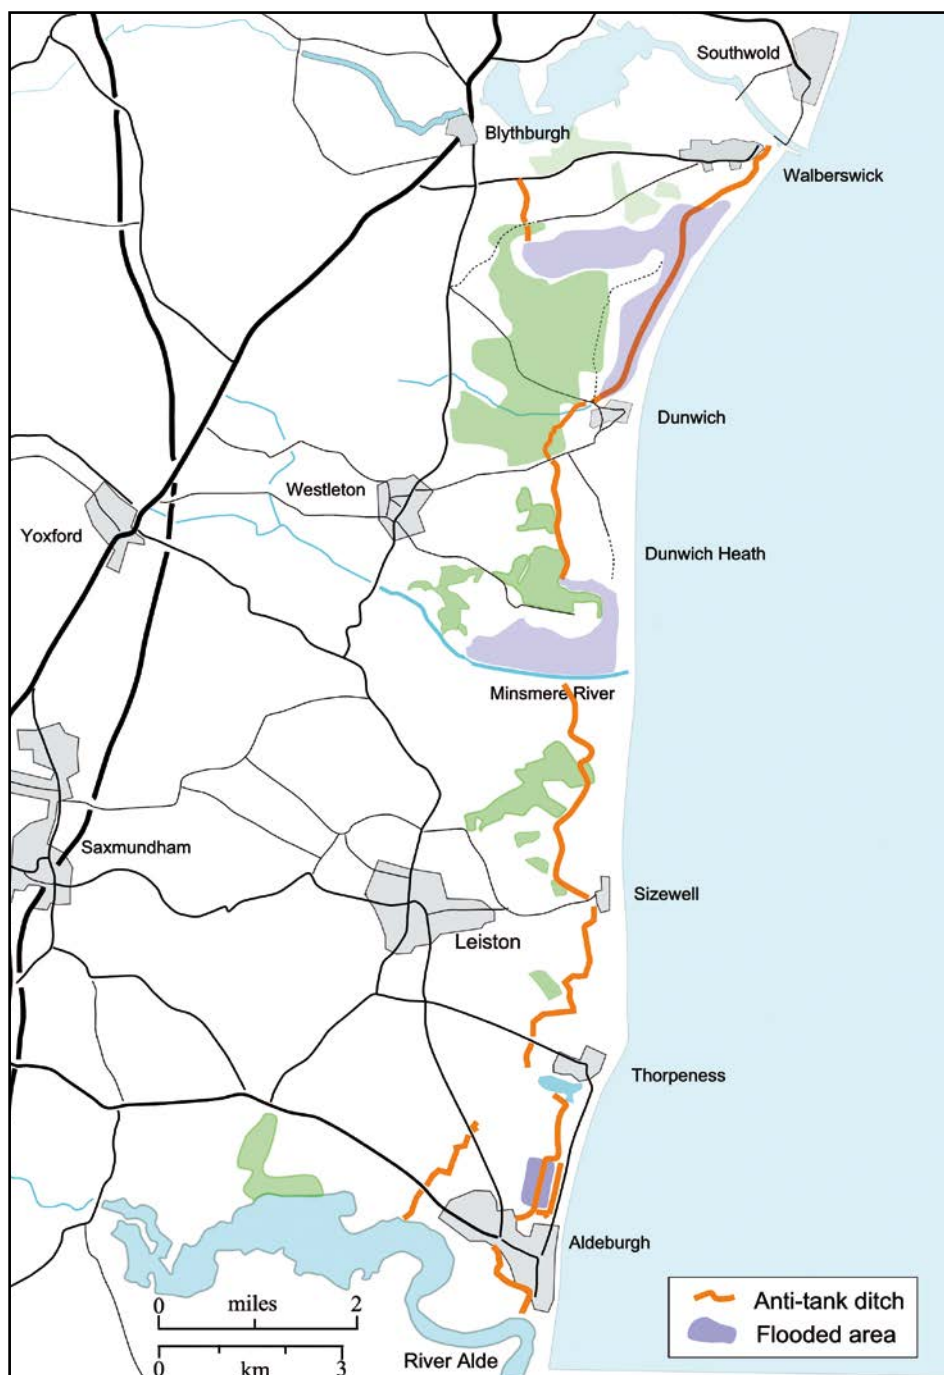
Figure 21. Map of anti-tank ditches in the area covered by this guide.

The second major change to the defence landscape in 1941 was the construction of anti-tank ditches. By the end of the year, a continuous anti-tank obstacle ran unbroken between the Blyth and the Alde (Figure 21). This obstacle was far from uniform, however. Wherever possible existing obstacles were used or adapted in order to lessen the length of ditch that needed to be excavated from scratch. The Dunwich river provided a ready-made ditch and was wide enough not to need any additional work. The smaller drainage ditches found in areas of marshland could be widened with relatively little effort, which proved an equally effective method of creating obstacles. Where possible, railway lines, with their cuttings and embankments, were also pressed into use.

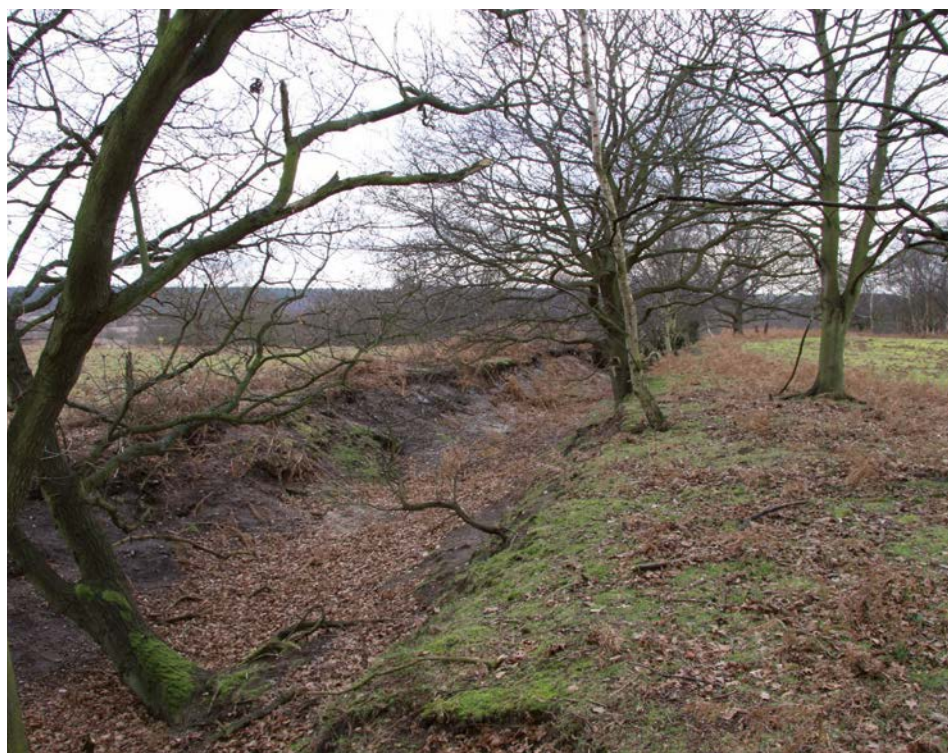
Figure 22. Anti-tank ditch at Walberswick showing the distinctive 'V' profile.

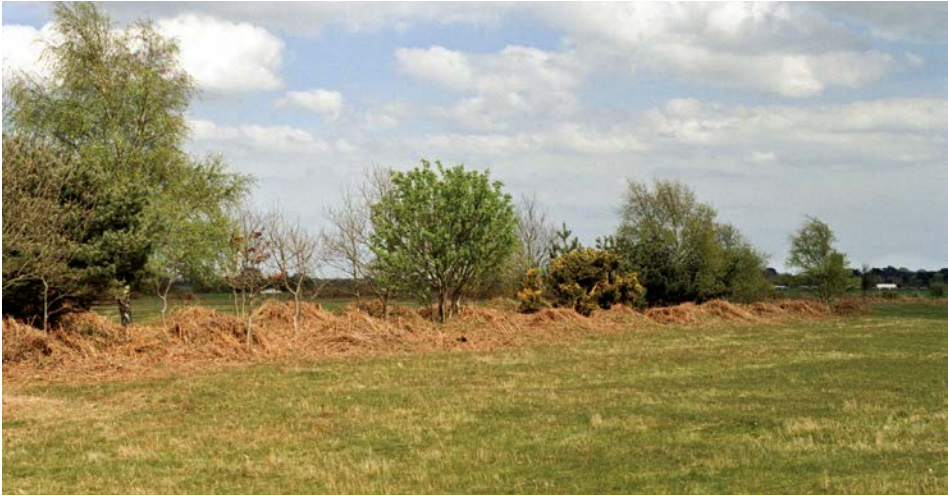
Figure 23. Extant anti-landing ditch, Sallow Walk Covert, Walberswick.

In addition to the building of beach scaffolding and ditches, 1941 also saw the widespread construction of anti-landing ditches. Today such ditches are normally known as anti-glider ditches, but in reality gliders had such a short landing run that their use could never be prevented. Instead, ditches could discourage the use of flat open areas as grassy airstrips by troop-carrying aircraft. For that reason they were constructed widely across the

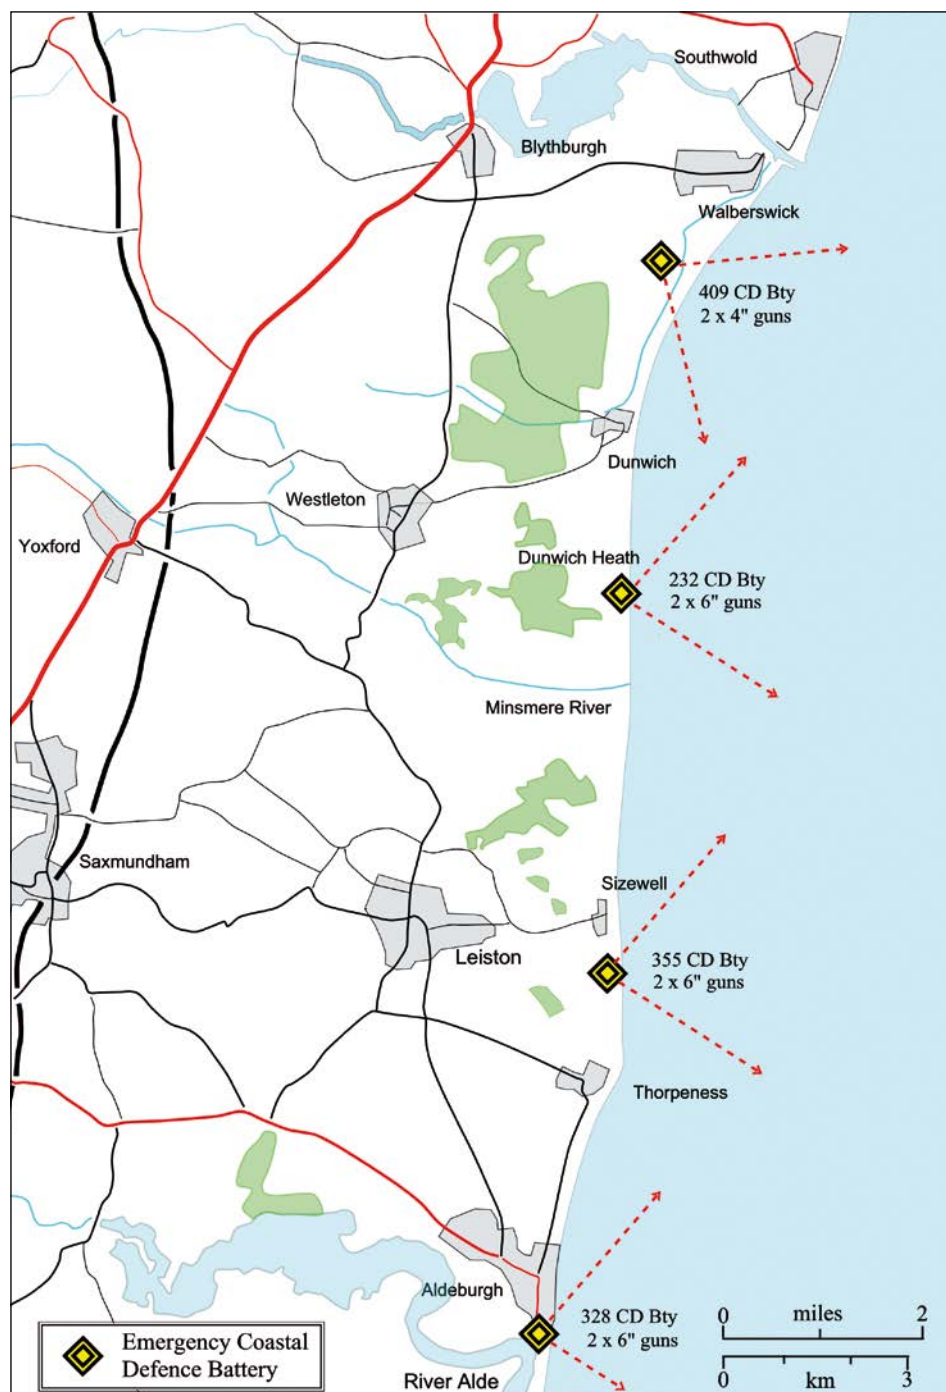
Figure 24. Distribution map of Emergency Coastal Defence Batteries in the area covered by this guide.

after the First World War and subsequently put into storage, brought back into service and placed in areas now thought to require additional defence. Aldeburgh, Sizewell and Dunwich were all provided with batteries and in 1941 an additional battery was built at Minsmere. (Figure 24)

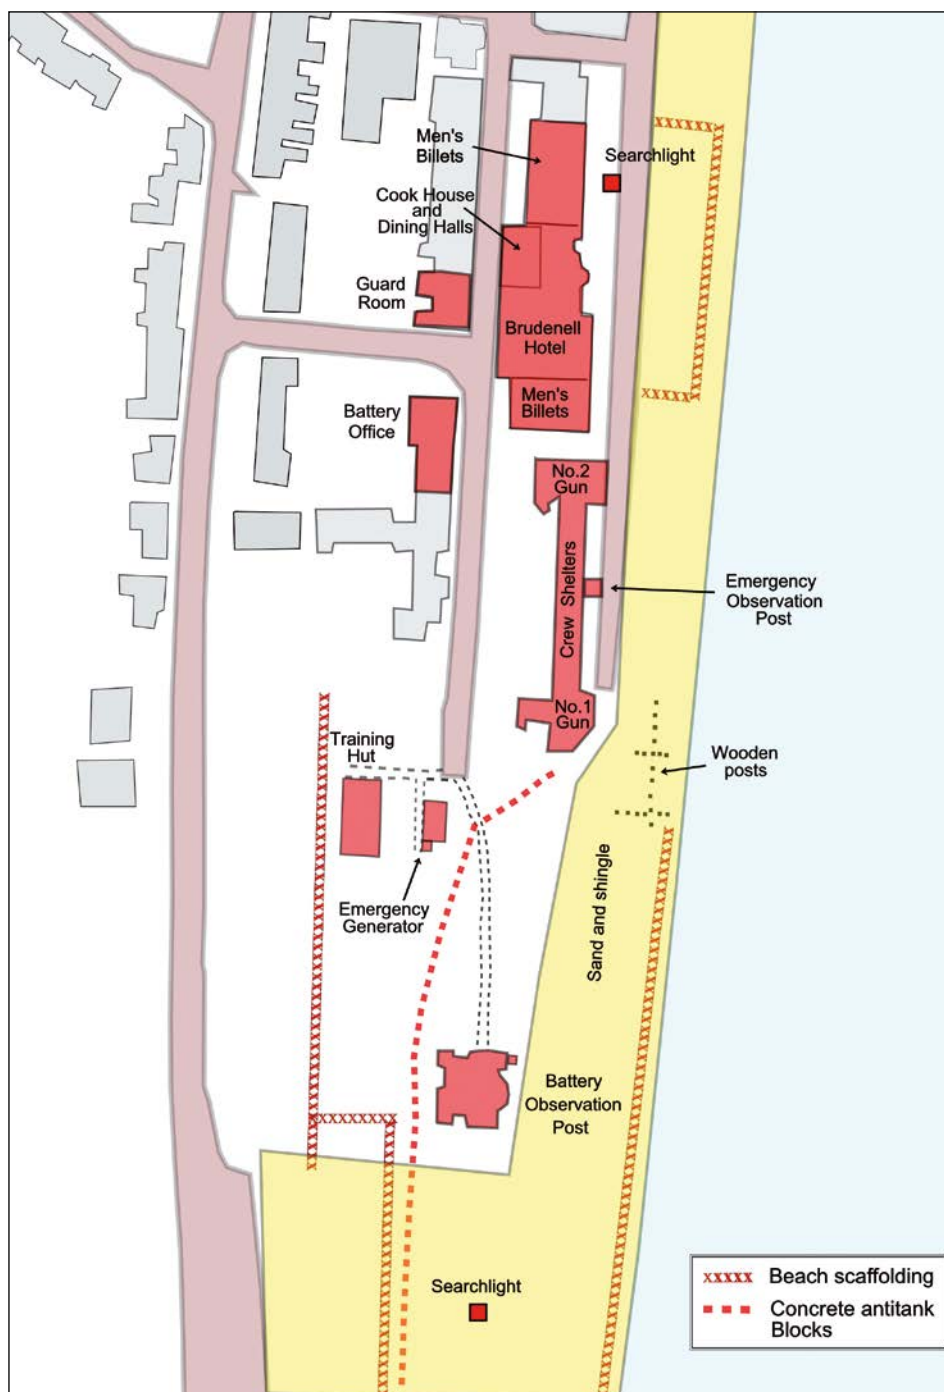
Figure 25. Plan of the Aldeburgh Emergency Coastal Defence Battery.

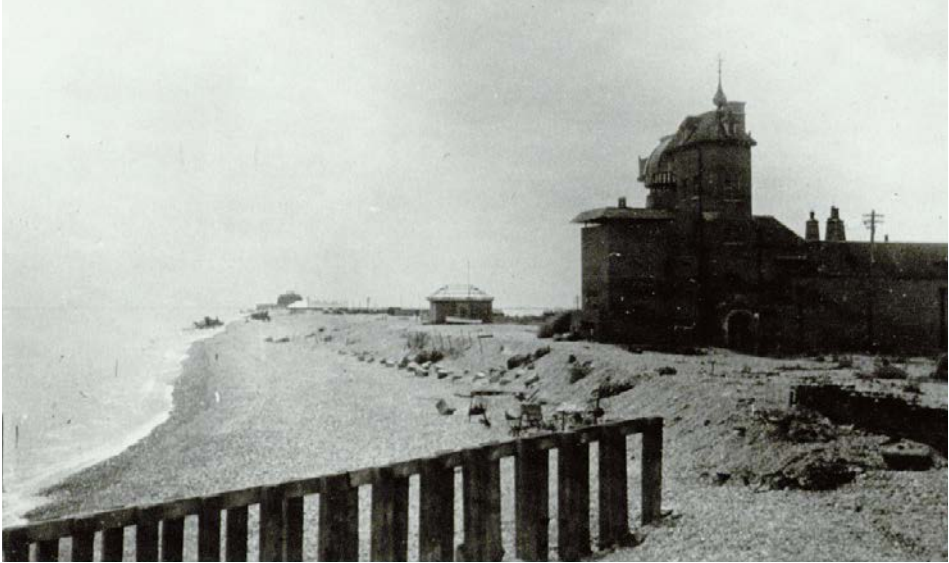
Figure 26. 1946 photograph of Aldeburgh showing the Battery Observation Post. (Ipswich Record Office)

(Figure 26). At Minsmere the observation post was built onto pre-existing line of coastguard cottages, which still exists today. A more elaborate scheme unfolded at Dunwich, where the concrete battery

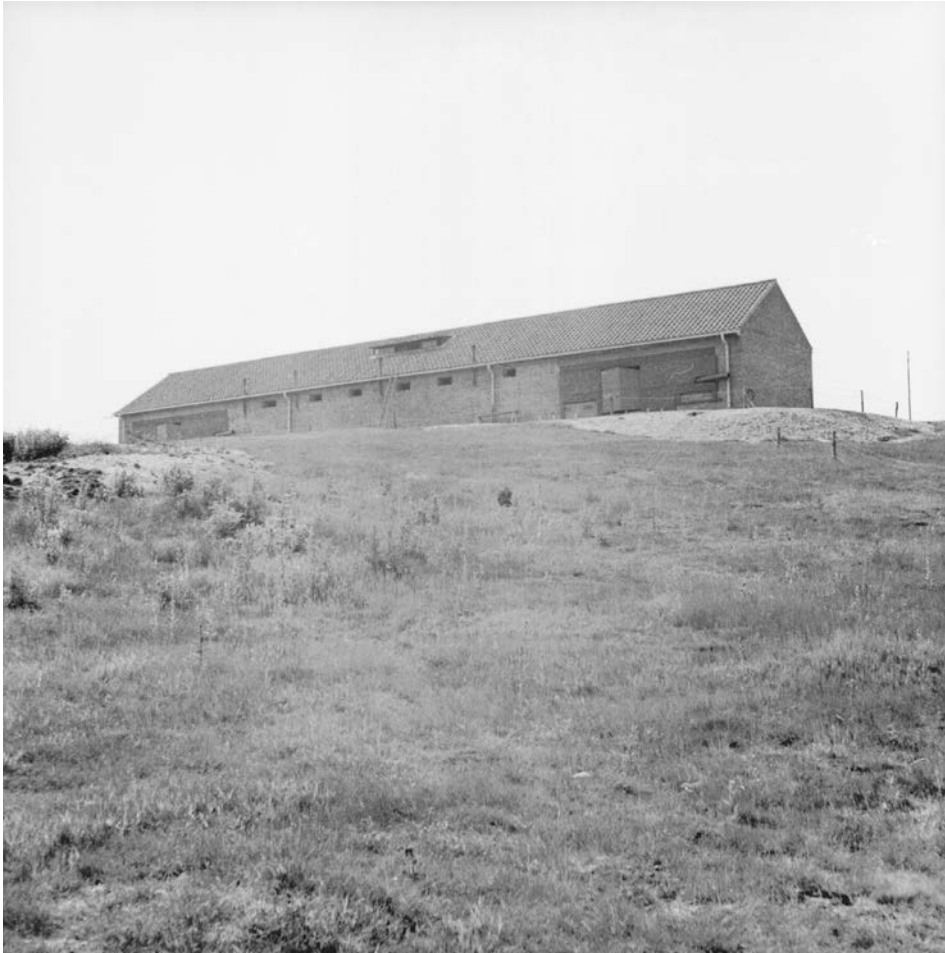
Figure 27. Camouflaged Emergency Coastal Defence Battery, Dunwich. (IWM H11452)

position was covered with a fake Dutch barn, which photographs show was a highly effective disguise (Figure 27). To further confuse the enemy, dummy batteries were established. One such battery, established between Aldeburgh and Thorpness, had sandbagged emplacements and dummy guns.
