A GUIDE TO SECOND WORLD WAR ARCHAEOLOGY IN SUFFOLK

Guide 2: Walberswick to Aldeburgh

Robert Liddiard and David Sims

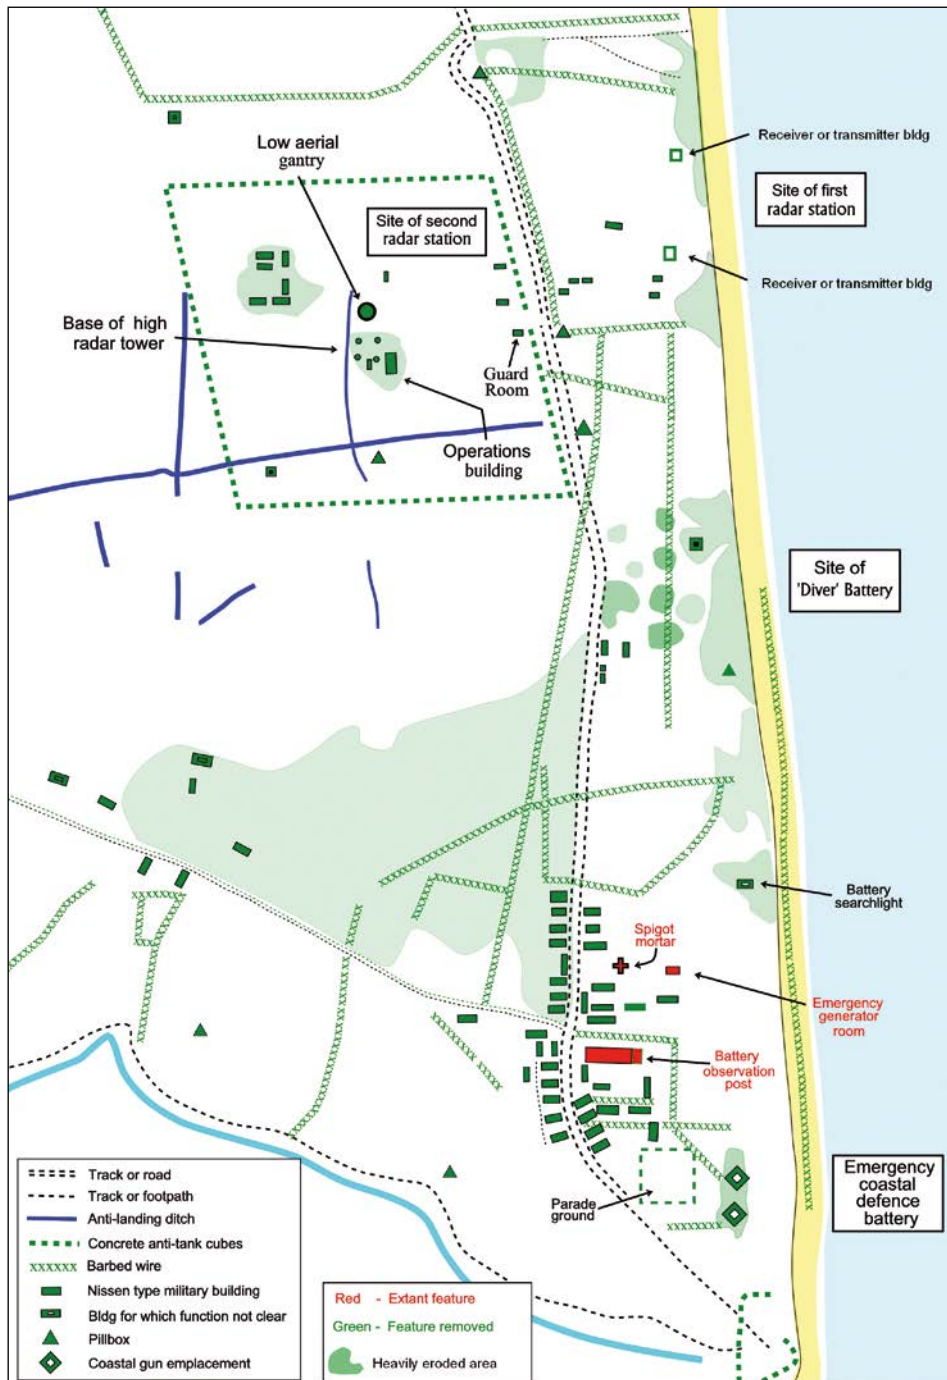
Figure 28. Plan of wartime structures on Dunwich Heath. Today only a fraction of what was originally built remains to be seen.

Over the winter of 1940-41 a replacement CHL was built on the site, which became operational on 15 February 1941. This conformed to a standard design, with an operations building and a single twenty foot gantry and was powered by mains electricity. On at least one occasion in 1941, this station was machine-gunned by enemy aircraft.

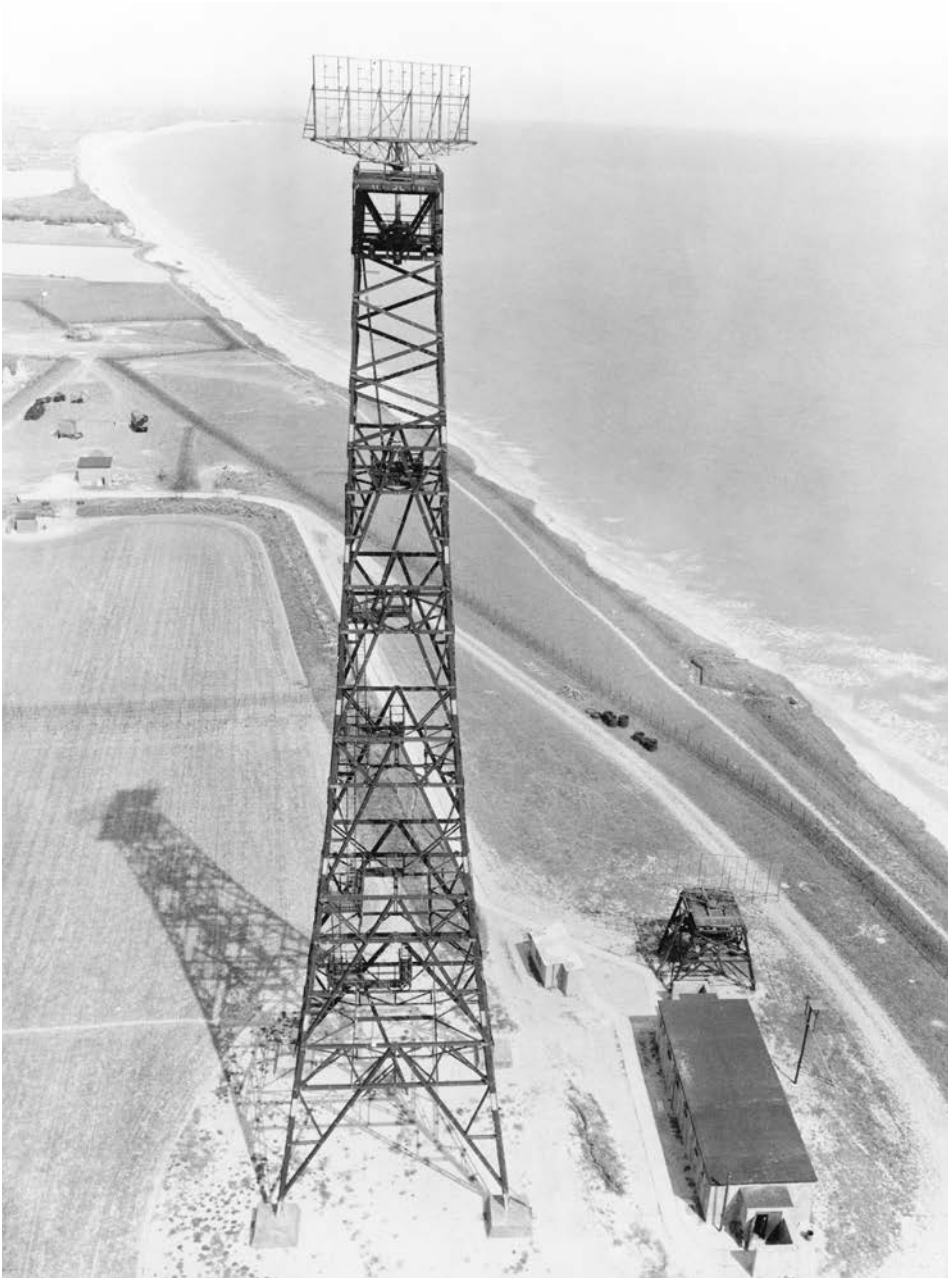
Figure 29. Hopton CHL Radar Station in Norfolk. This photograph gives a good impression of what was in place at Dunwich. (IWM CH15183)

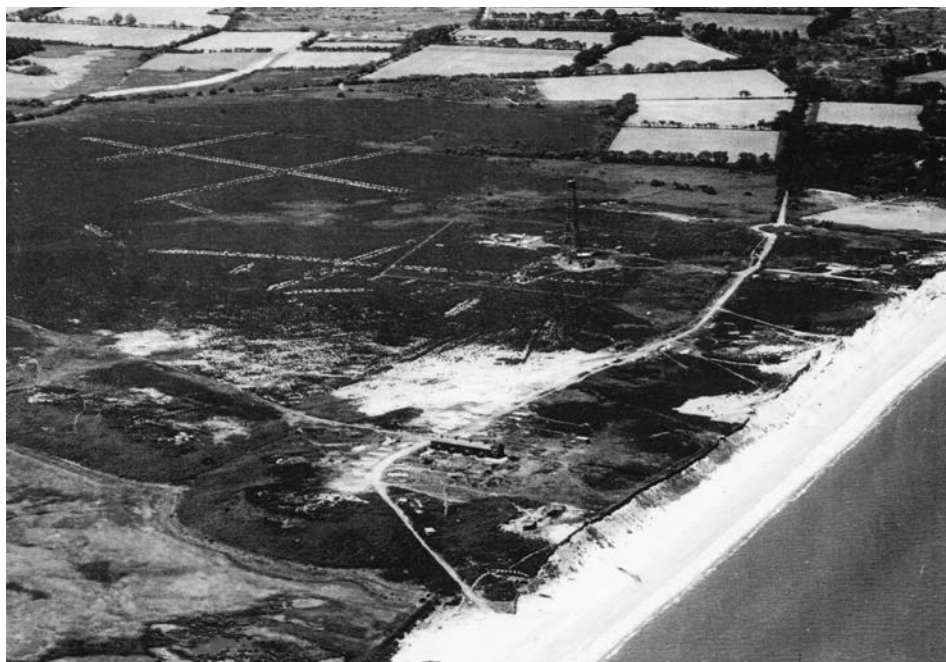
Figure 30. Aerial photograph c.1946 showing the radar station and other anti-invasion defences. (courtesy of National Trust and Stuart Bacon, Suffolk Underwater Studies). See also Figure 44, which shows the gantry of the radar station in the background.

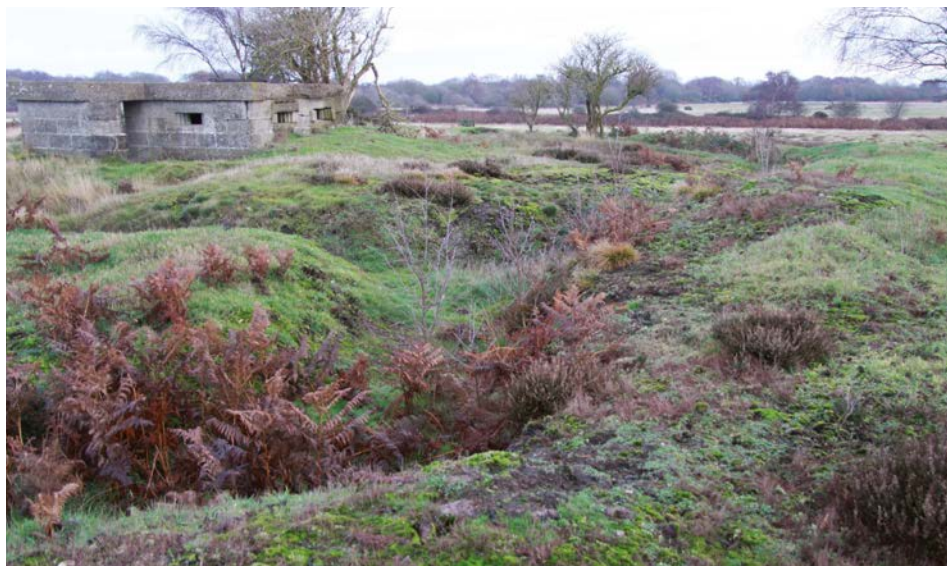
Figure 32. Suffolk Square pillbox placed within an earlier training earthwork at North Warren, Aldringham.

area are numerous examples of evidence for training activities. At North Warren, near Aldeburgh, a substantial earthwork which stretches over several hundred metres is almost certainly the result of a practice exercise, in which troops were required to construct a mock company position (Figure 32).

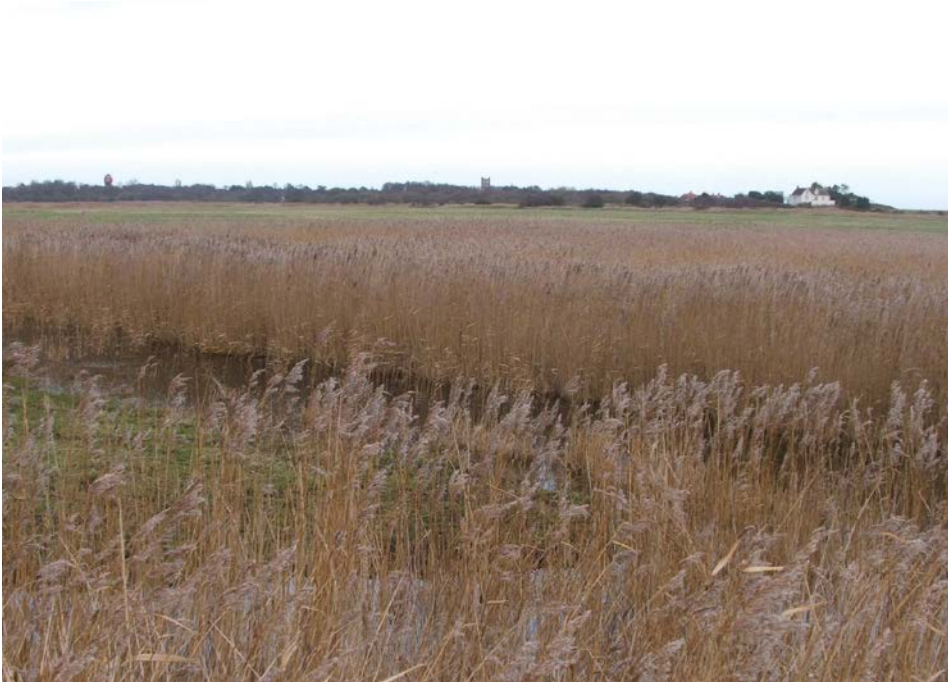
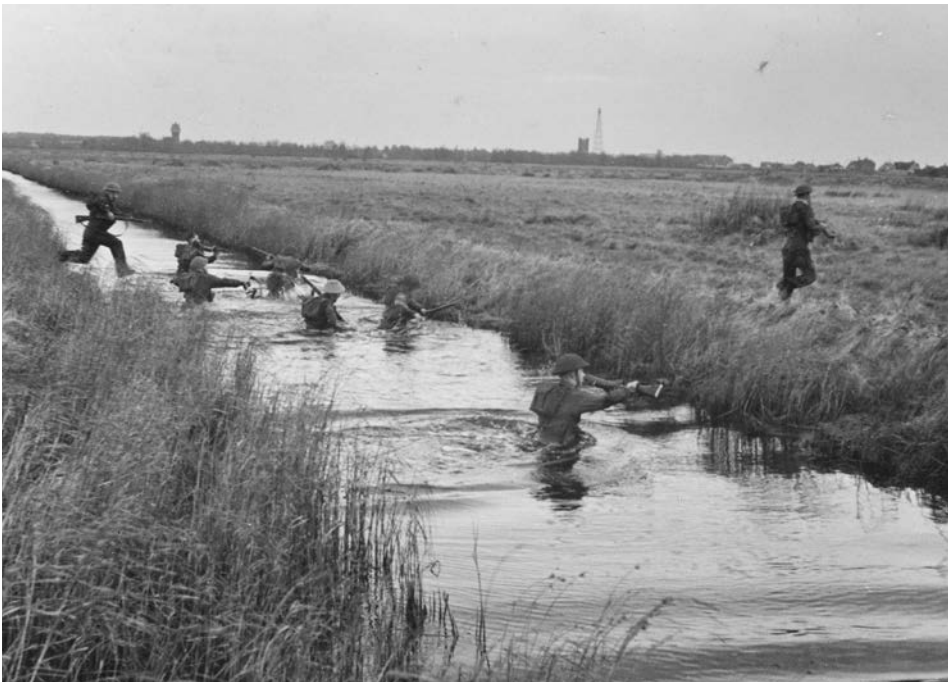
Figures 34 and 35. Aldeburgh Battle School 'then and now'. Below is shown obstacle crossing at Thorpeness. Troops are crossing a drainage ditch that had been widened in 1940 to create an anti-tank obstacle and was then re-used as a training feature. (IWM H 27347).

The training regime was characterised by hard physical exercise, route marches and a series of 'hardening up' exercises, where men practised while under live fire (Figure 33). The existing anti-invasion defences provided a ready-made source of obstacles that could be utilised for training purposes, chiefly as hazards that had to be negotiated (Figures 34 and 35).

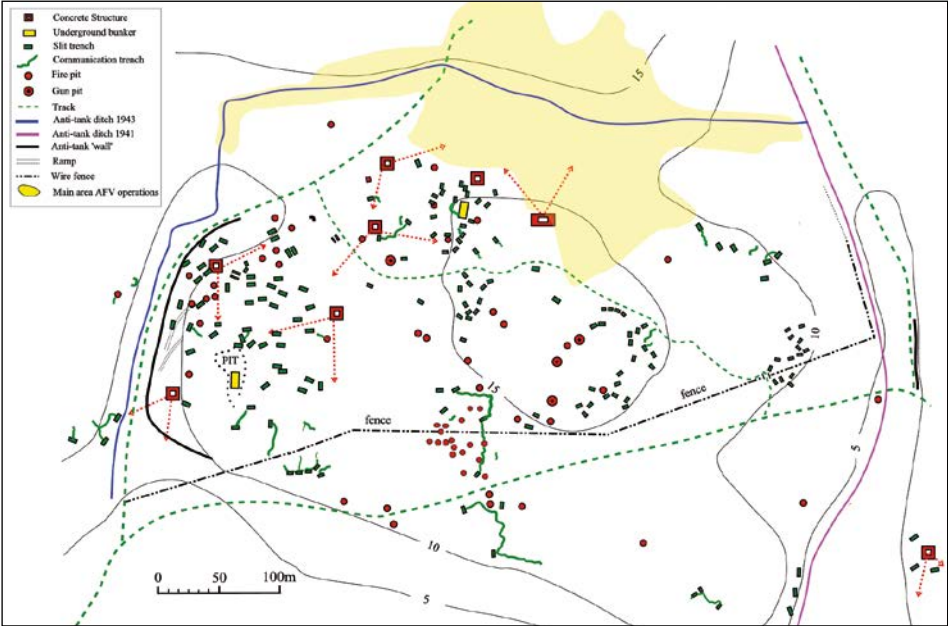
Figure 36. Plan of the 'Hedgehog' built for Exercise 'Kruschen' in 1943.

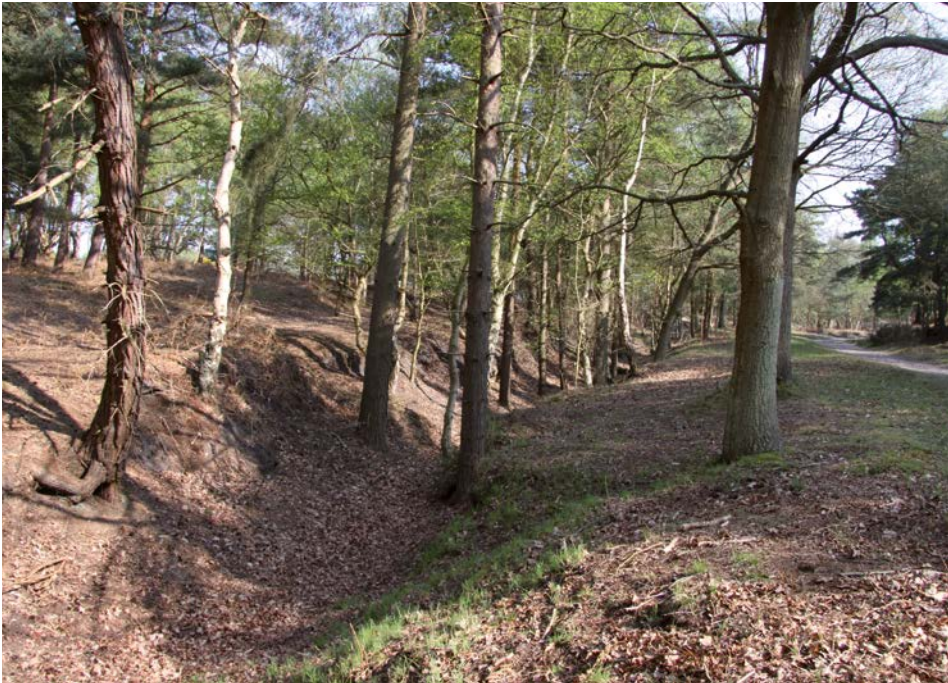
Figure 37. Anti-tank ditch forming the western boundary of the Kruschen 'Hedgehog'.

The boundary of the hedgehog was a large anti-tank ditch that stretched for several hundred metres along the site's northern and western sides (Figure 37). Along the northern edge it is heavily eroded, evidence for the number of armoured vehicles that crossed it during the exercise. On the eastern side the hedgehog boundary is a length of anti-tank ditch dug in 1941. To the south the escarpment forms a natural defence.

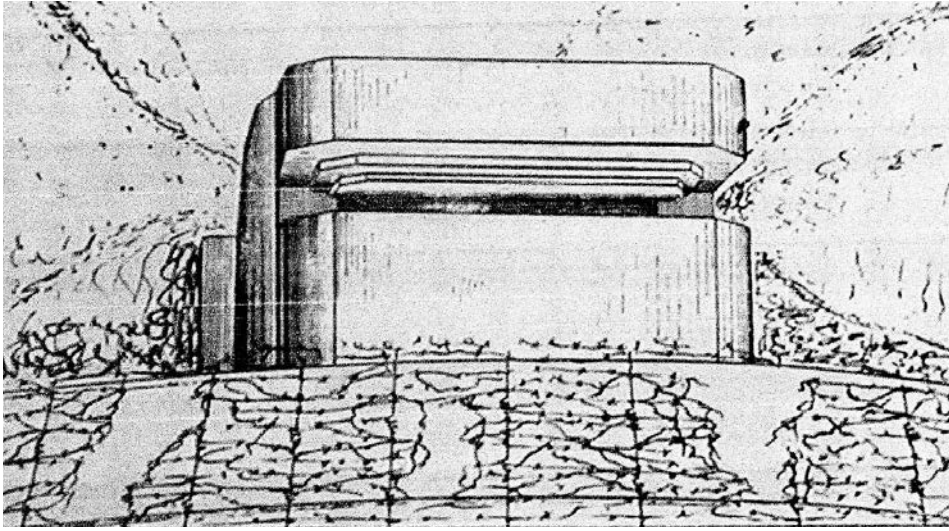
Figure 38. Illustration from a wartime British intelligence document concerning German fortifications on the Atlantic Wall, showing the kind of concrete emplacement then under construction.

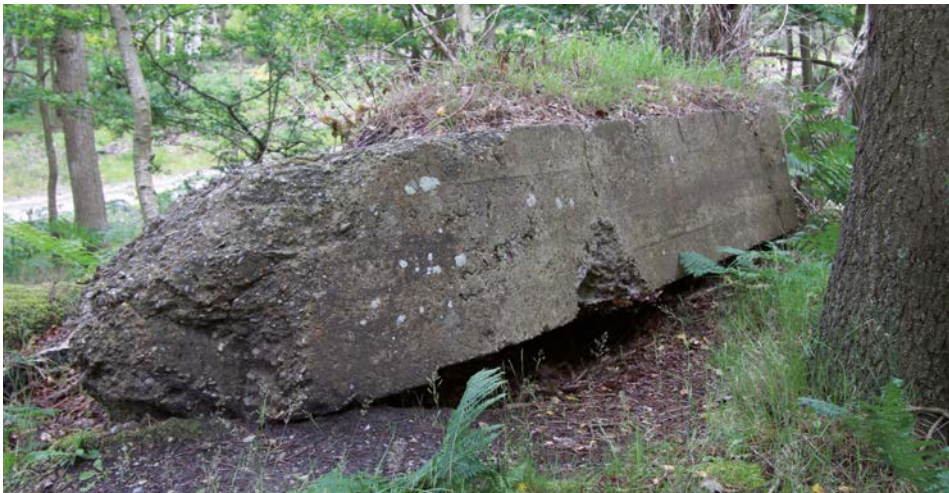
Figure 39. Concrete pillbox built for Exercise Kruschen to replicate German fortifications. Its ruined state today is a result of its being blown up by engineers training for the D-Day landings in late 1943 or early 1944.

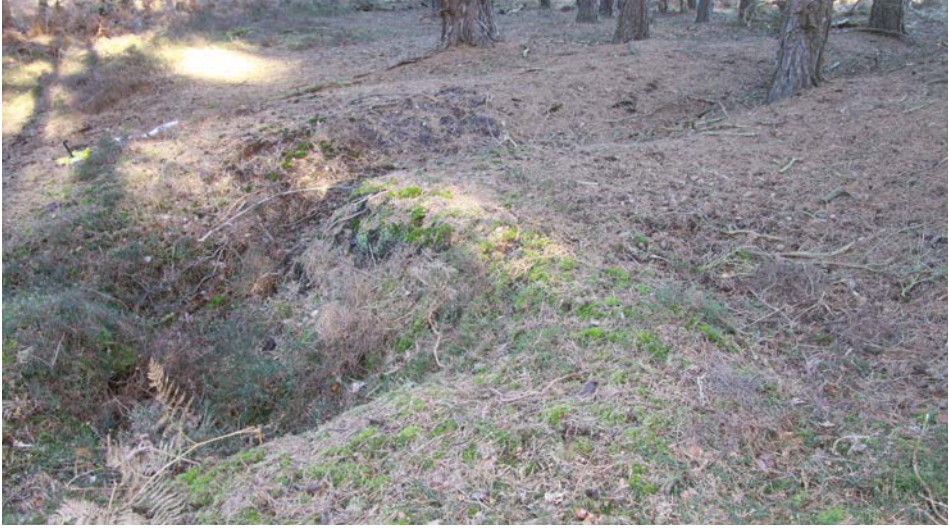
Figure 40. 'German' trench forming part of the 'Hedgehog' defences.

slight sinuous ribbons of shallow trenches to larger pits and depressions. The majority take the form of shallow trenches that snake across the topography and often either follow ridgelines or lie on the forward slopes of the escarpment. These often interconnect with rectangular or circular pits the spoil from which is heaped up onto one side. A smaller number of pits are more 'keyhole' in shape. These earthworks are the remains of mock German trenches for infantrymen armed with rifles and machine guns. (Figure 40)

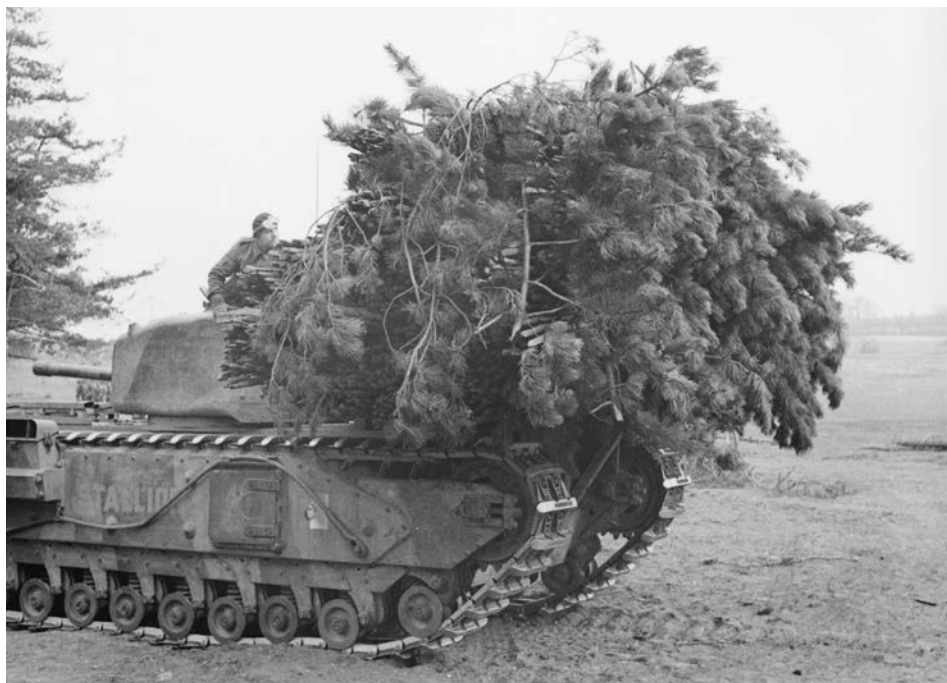
Figure 41. Fascine-carrying tank, Exercise Kruschen. (IWM H 29035)

The hedgehog and the surrounding area were the scene for mock assaults that tested equipment and techniques. Various forms of flamethrower were trialled, as were different devices for crossing the anti-tank ditch, breaching the minefield and clearing the barbed wire. The dropping of a fascine (a bundle of wooden palings) by a tank into the anti-tank ditch was perfected, as was the vehicular use of the 'snake', a metal pipe full of explosives that could be used to blow a path through the minefield and barbed wire (Figures 41 and 42). Just as important, however, were the various battle drills that were pioneered, where the precise placement of men, vehicles and weapons was tested. During a 'live run' tanks, artillery, mortar fire and small arms were all used to practice breaching the hedgehog defences and then clearing the pillbox complexes. One veteran recalled that the vehicles churned up so much dust from the sandy soil that the heath resembled the desert in North Africa and that such an unusually high level of ammunition was provided for the exercise that men placed bets on whose vehicle fired off the most machine gun rounds during mock attacks.

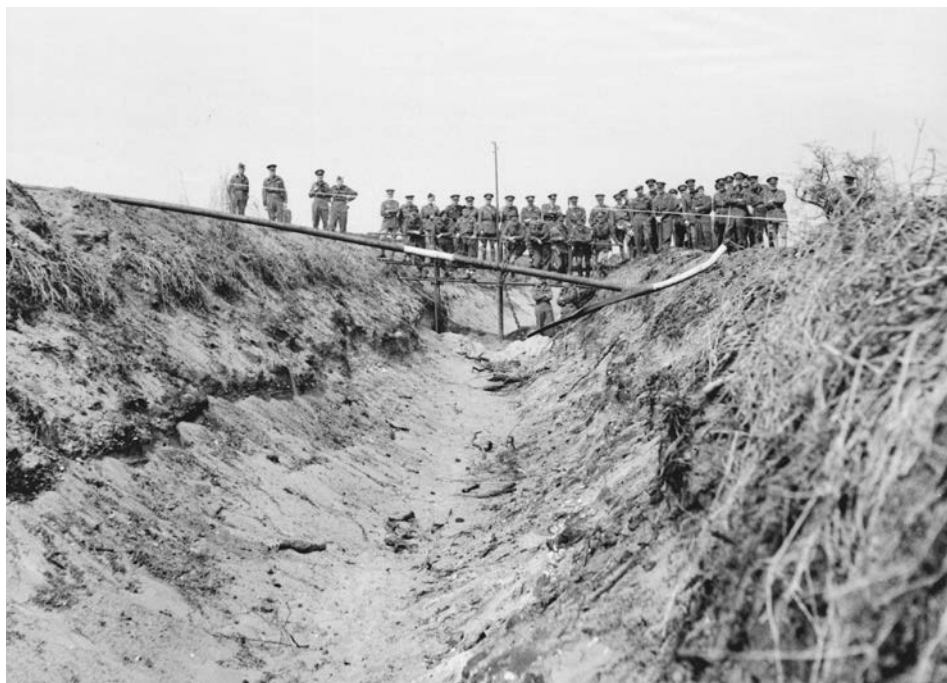
Figure 42. Senior officers watching a demonstration of the 'Snake', an explosive device used for clearing a passage through minefields and barbed wire. (IWM H 29057)

The final results of Kruschen were showcased in two demonstrations on 14 April and 8 May, both of which were attended by senior military and political figures. The exercise was deemed to be a success, as it had perfected the use of the Snake, proved the effectiveness of the fascine and also prototyped an all-arms drill that could be used as a basis for troops training for the D-Day landings. Kruschen was only the beginning, and the knowledge gained was refined over the next twelve months, but it kick-started the process that resulted in the success of Operation Overlord on 6 June 1944.

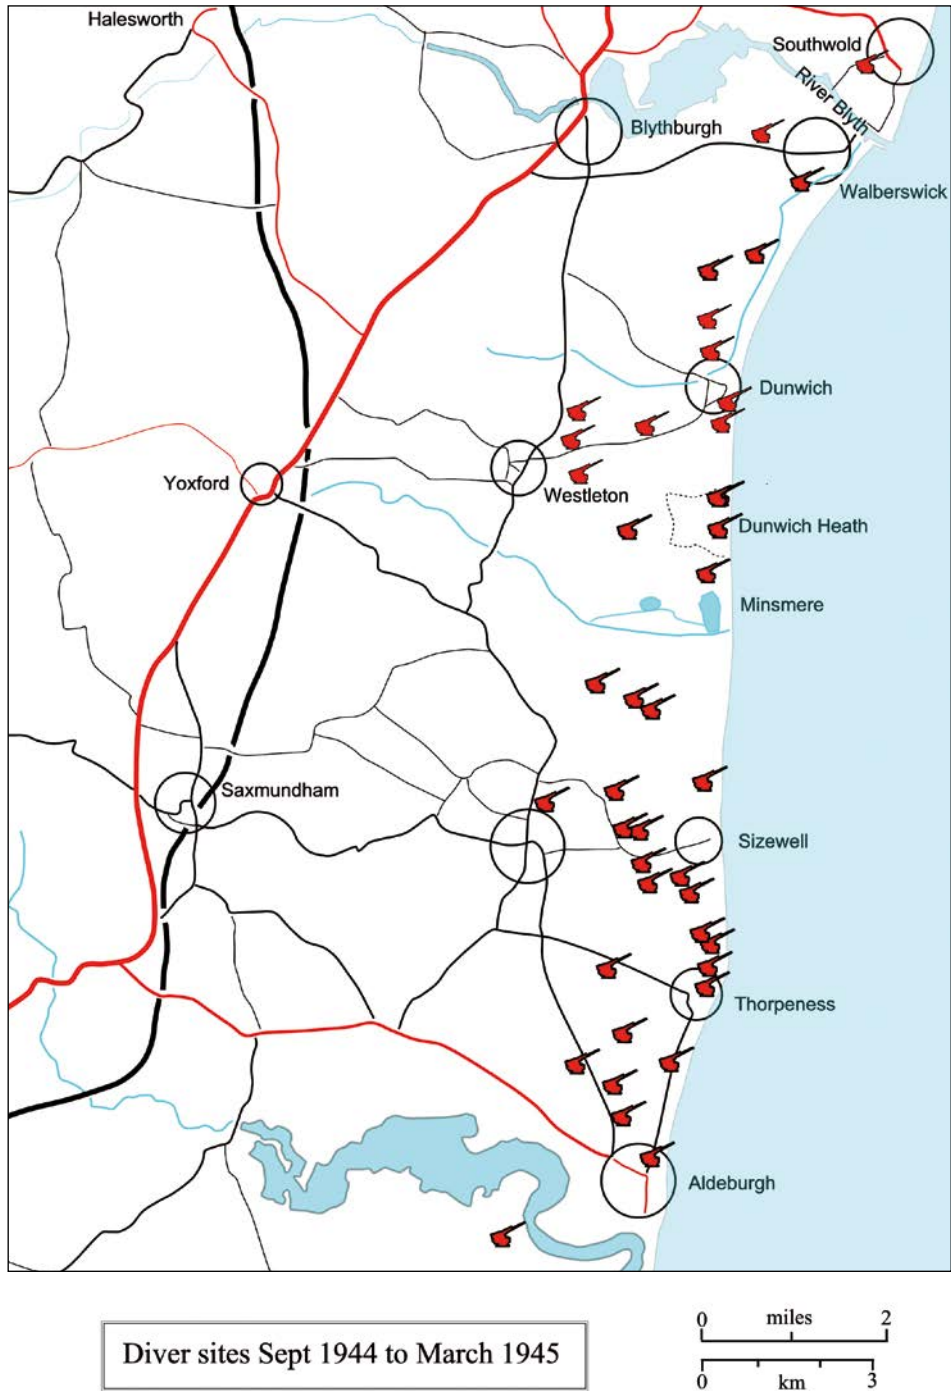
Figure 45. Distribution map of Diver gun sites in the area covered by this guide; each symbol represents a battery of four 3.7inch heavy anti-aircraft guns.

In response, in September 1944 Anti-Aircraft Command established the 'Diver Strip', which stretched from Clacton to Great Yarmouth on the east coast. In the area covered by this guide there were approximately forty separate sites connected with Diver, including searchlight positions as well as gun batteries. For the majority of sites there are only traces left above ground, but aerial photographs give an idea of what was originally in place (Figure 45).

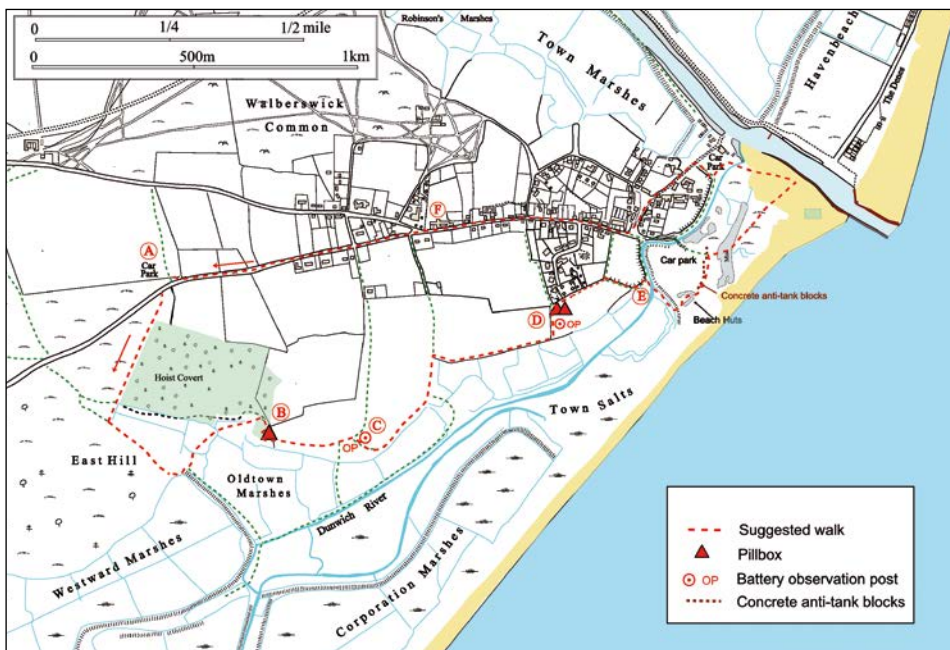
Figure 49. 'War Walk' at Walberswick, showing the principal 1940 defences.

The 1940 Defences: A Round of Walberswick (Figure 49)

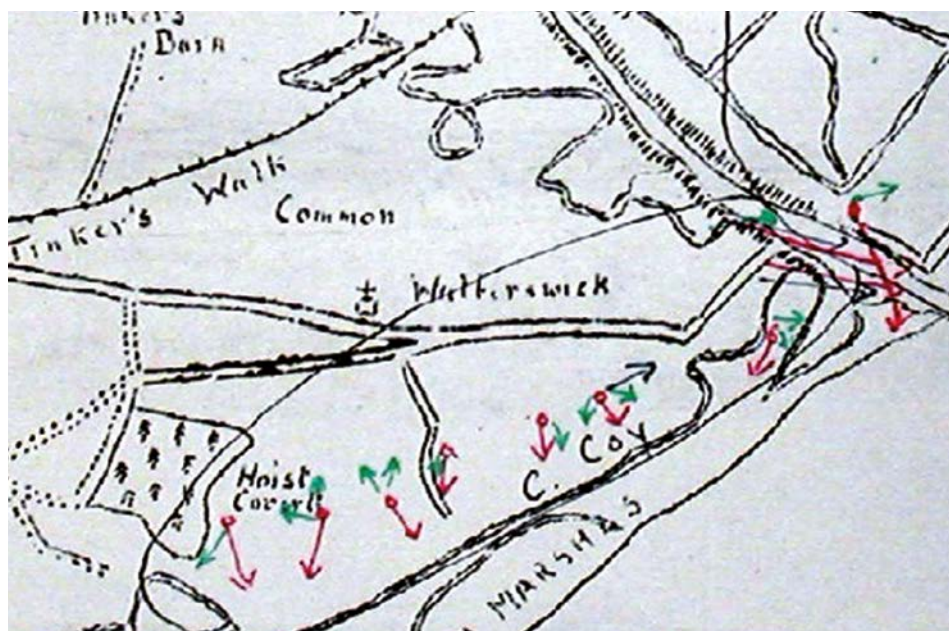
Figure 50. Map of 'C' Company 2nd/4th South Lancashire Regiment's dispositions in the summer of 1940. (The National Archives)

Walberswick is one of the best places to appreciate Ironside's 'coastal crust' as it existed on the ground and the broader thinking behind the anti-invasion landscape in this part of Suffolk. Here it is possible to walk the length of the defensive line of 'C' Company, the 2nd/4th South Lancashire Regiment, who constructed the defences here in the summer of 1940. (Figure 50)

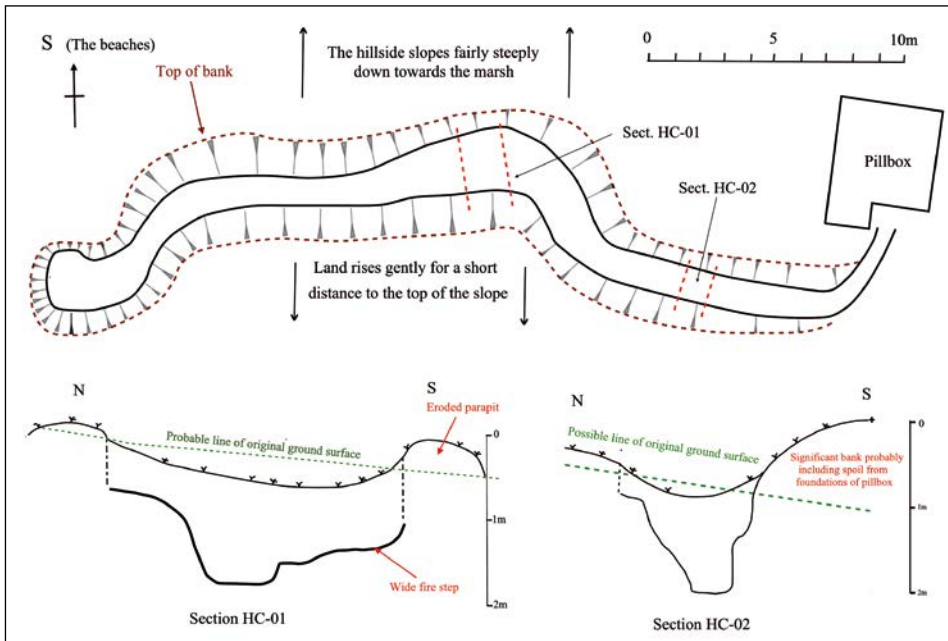
Figure 51. Plan of ten-man section position, Hoist Covert.

Here there is a unusual survival of a pillbox with the remains of its trench system intact. Today the site is heavily overgrown but this is the reason for its survival, as regenerating woodland since 1945 has preserved the earthworks of the former trench. Although partially filled in at some point after the war, enough remains to give some idea of the original size. (Figure 51 and Figure 52)

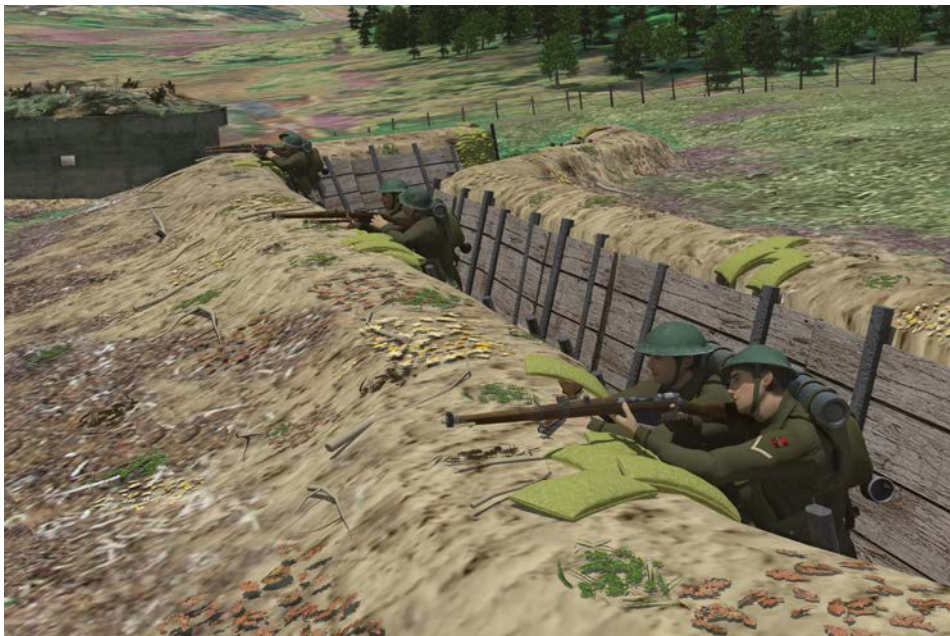
Figure 52. Computer reconstruction by the University of East Anglia of the Hoist Covert position as it may have looked in September 1940. (Virtual Past)

The pillbox is a 'Suffolk Square' typical of this part of Suffolk. A section of communication trench leads from the entrance and connects with a much larger earthwork that was a section of 'fire trench'. The position was for a ten-man section of infantrymen and its location marked the extreme right flank of 'C' Company, the 2nd/4th South Lancashire Regiment.

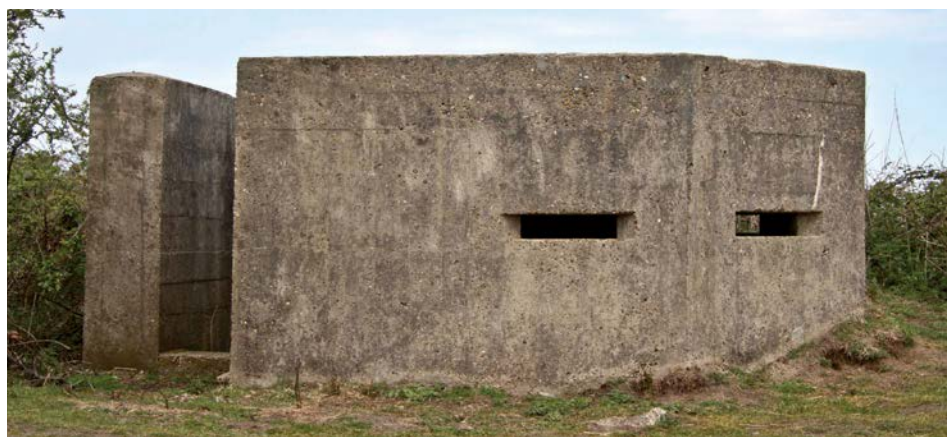
Figure 53. Artillery Observation Post at Walberswick. The commanding location gave maximum visibility for the spotters, whose guns were located at Sallow Walk Covert, a little inland from Walberswick.

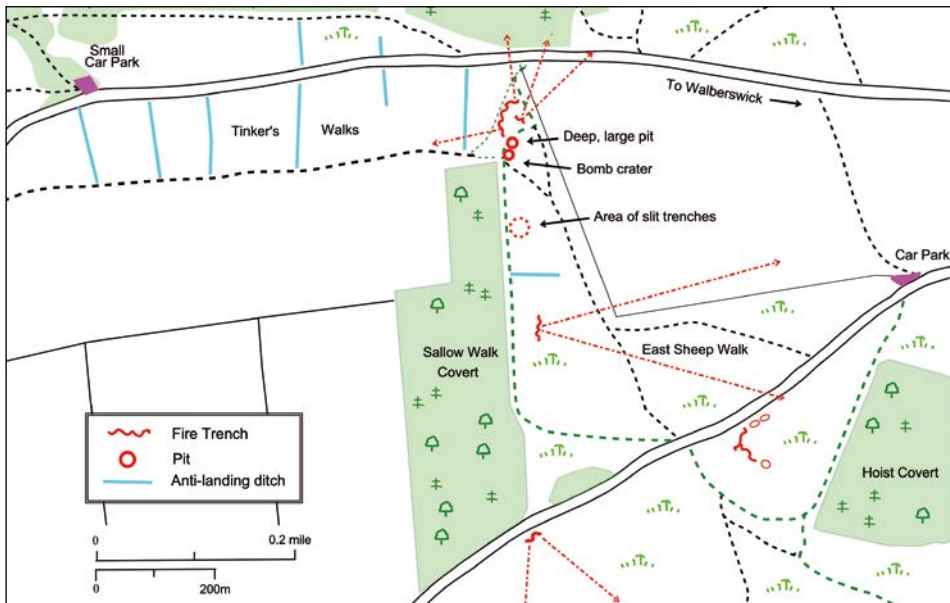
Figure 56. Plan of military archaeological remains, Sallow Walk Covert. This small area contains a variety of earthworks, some of which can be related to anti-invasion defences, while others are almost certainly training works.

place. These do not look like the kinds of trenches found in British military manuals and so it is possible that they are ‘German’ positions, built in the later part of the war for troop training and used during mock attacks.

Some support for this idea is provided by the existence of shallow rectangular pits littering this part of the Walk. These do resemble the kind of earthwork found in training manuals and are probably the remains of ‘slit trenches’, which were often dug by troops on exercise; when they were not intended to be occupied for any length of time they were not dug to any great depth. It is not inconceivable that in this part of the Walk we are looking at the remains of a training exercise where troops had to take a German position and then quickly ‘dig in’ afterwards, before moving on to their next task.

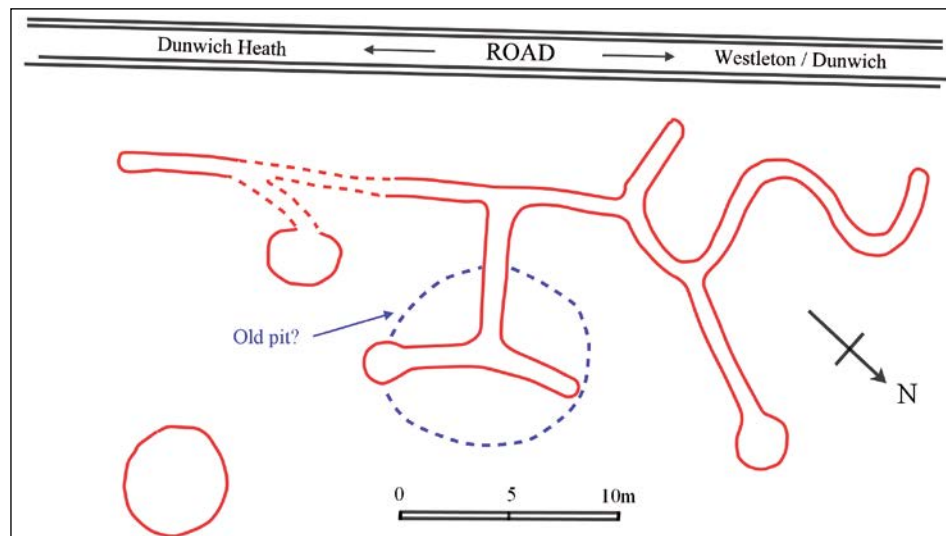
Figure 57. Plan of section position alongside Dunwich Road. This was a position for ten men and was primarily intended to protect the adjacent flat farmland from German troops landed by glider, aeroplane or parachute.

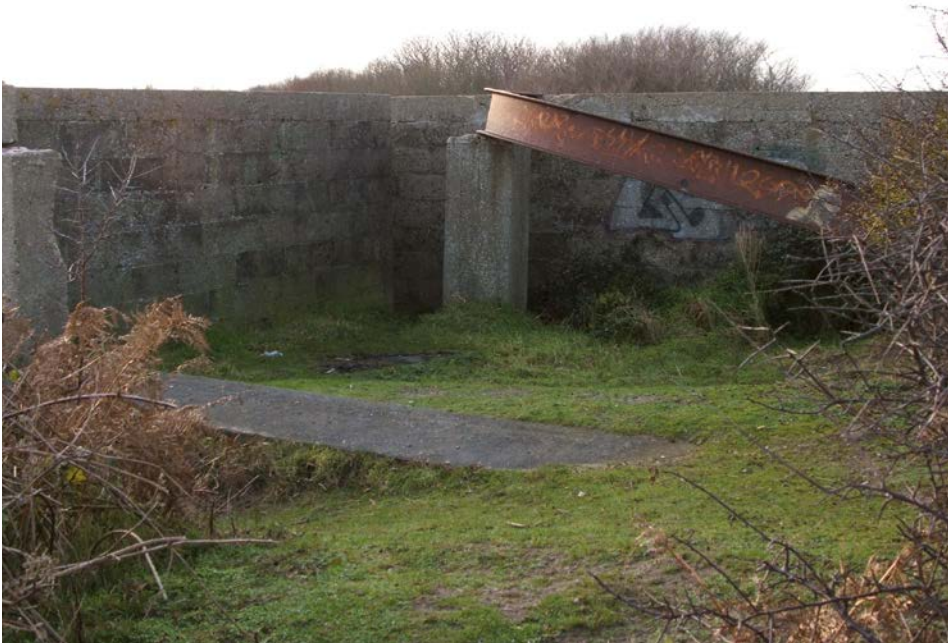
Figure 58. Concrete emplacement for 18 pounder gun nicknamed 'John', built in 1940.

Despite the importance of artillery in the defence of the coastline, archaeological survivals of gun emplacements are rare. One very unusual example of a concrete emplacement is to be found at Thorpeness (TM 476606). This is the position for an 18-pounder field gun which was placed here so that it could fire on Sizewell beach. The emplacement was built in May or early June 1940 when the gun itself was moved to Thorpeness from Kessingland, further north. This was one of five lone guns (either 18 pounders or 4-inch ex Naval guns) that were placed along vulnerable parts of the Suffolk coast and sited so they could fire directly onto the beaches. The one at Thorpeness was nick-named 'John', the others were 'Matthew', 'Mark', 'Luke' and 'St Peter'. The emplacement itself is of

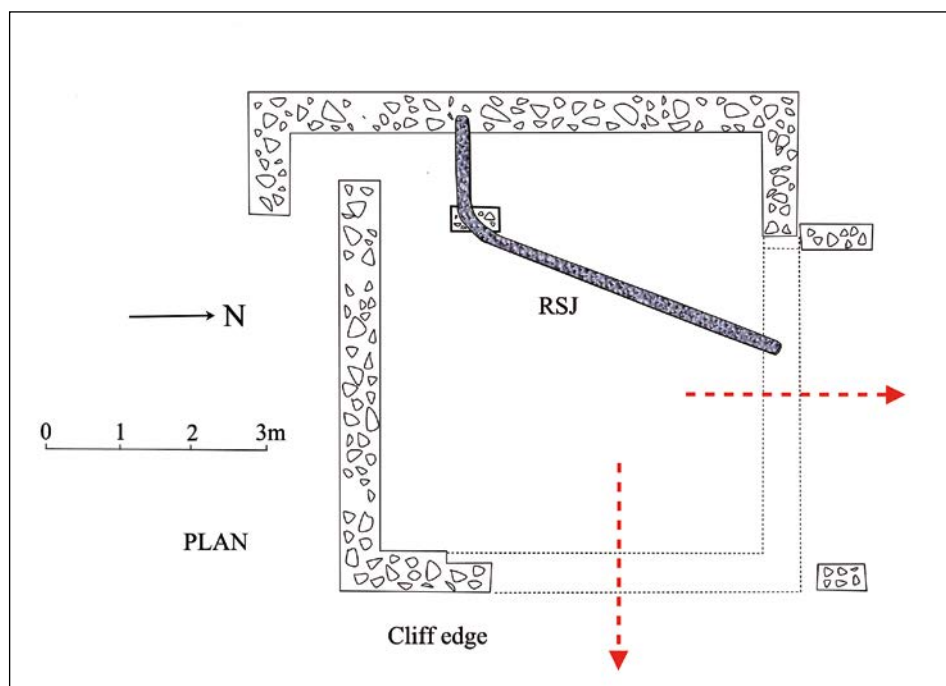
Figure 59. Plan of 'John' emplacement.

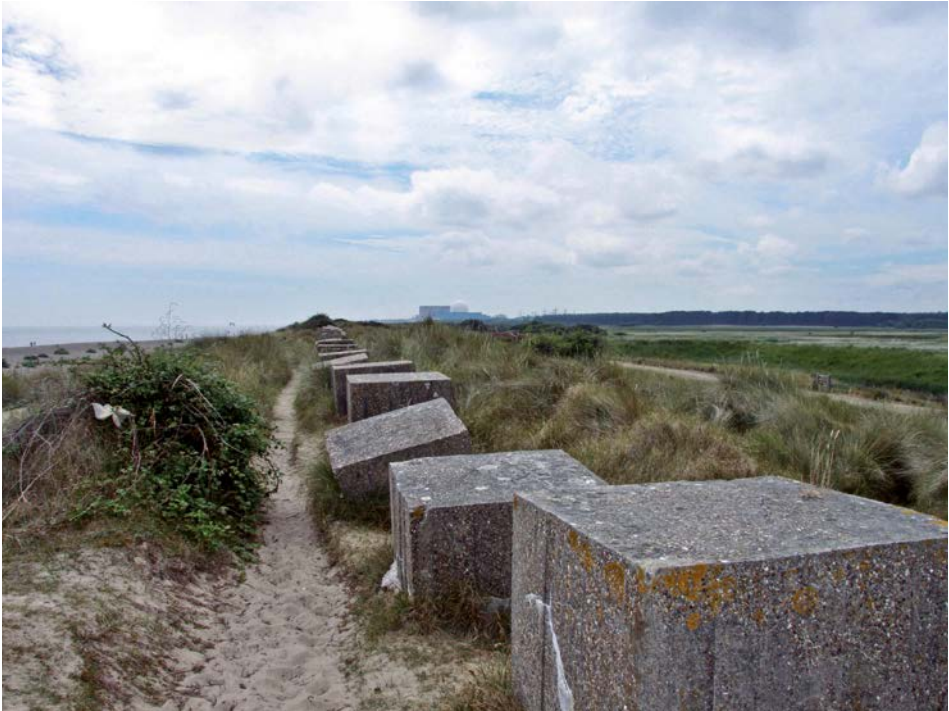
Figure 60. Anti-tank cubes, Minsmere Levels. Here the long run of blocks formed a continuous obstacle.

The best surviving length of anti-tank cubes in Suffolk is to be found on the Minsmere Levels at TM 478664. Here several lines of cubes run for hundreds of metres and some sense of how they transformed the landscape still remains.

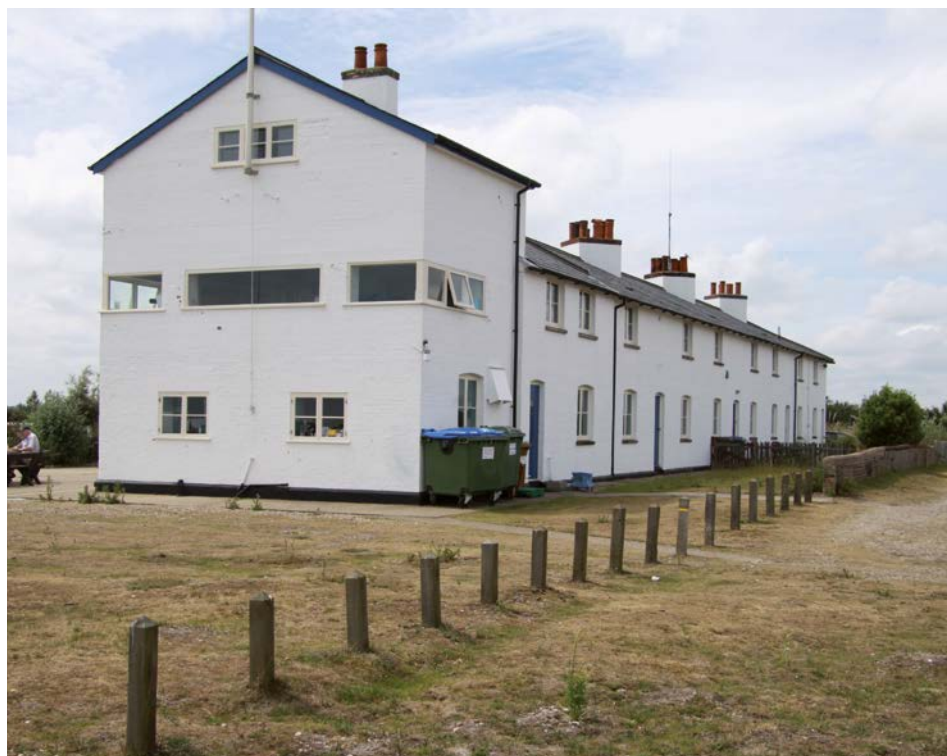
Figure 61. Battery Observation Post for Minsmere Emergency Coastal Defence Battery, built up against the row of cottages for camouflage.

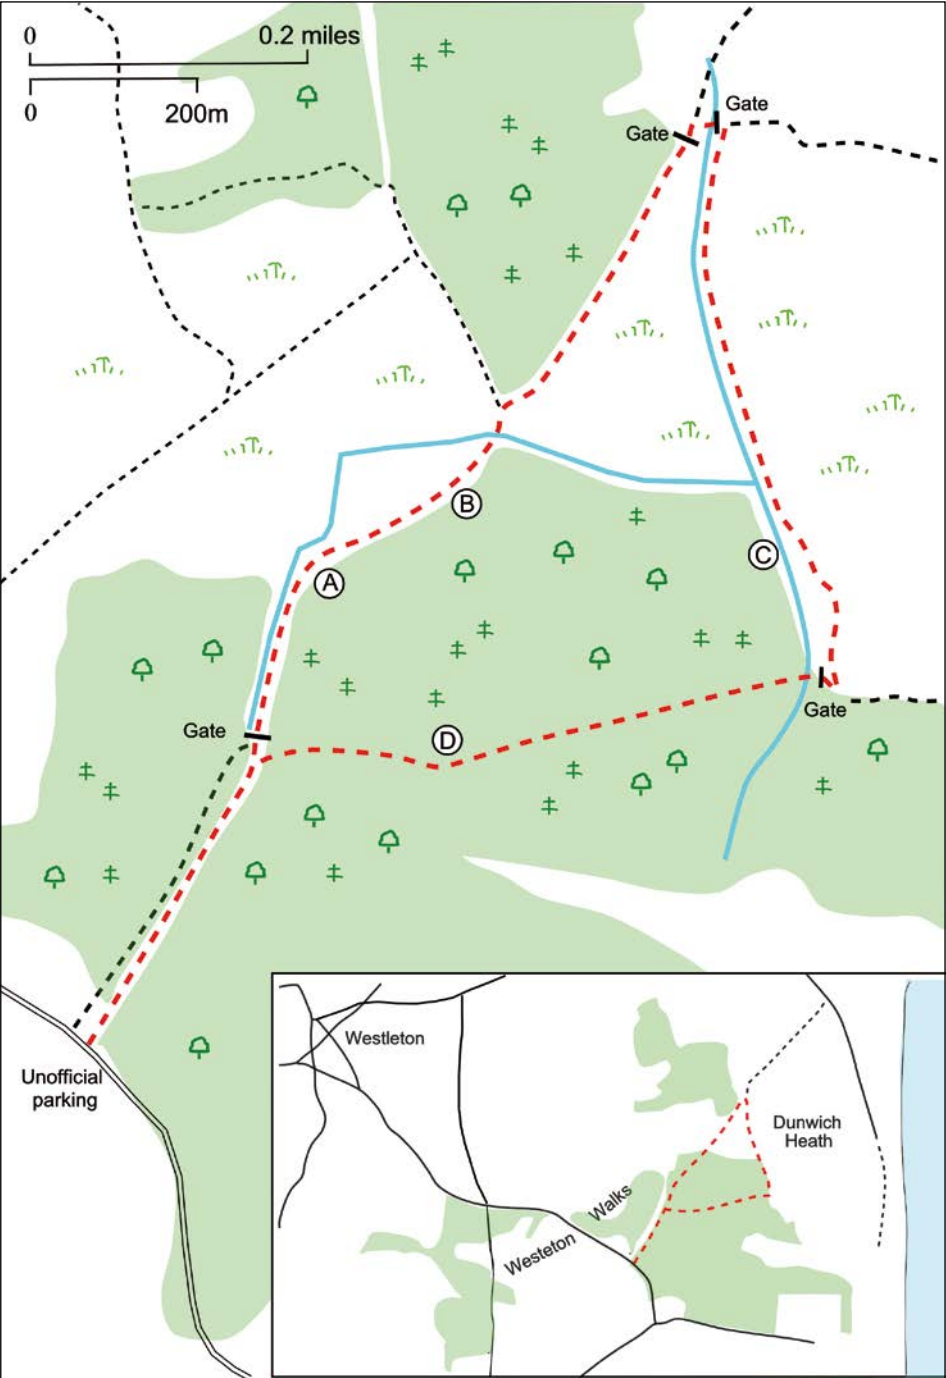
Figure 62. 'War Walk' at Westleton Walks, along the bounds of the 'Hedgehog' built for Exercise Kruschen, 1943.

The well-preserved remains of Exercise ‘Kruschen’ can be seen from the public footpath that runs across RSPB and National Trust land at Westleton Walks and Dunwich Heath. A convenient starting point is TM 461673. From here follow the path north leading to TM 463680 The modern gate stands just outside the ‘hedgehog’ and broken remains of concrete pillboxes can be seen on the ground.

From here follow the path north, which runs through what would have been the hedgehog defences, Point ‘A’. On the left the anti-tank ditch survives particularly well; this stretch was built specifically for the exercise. On the

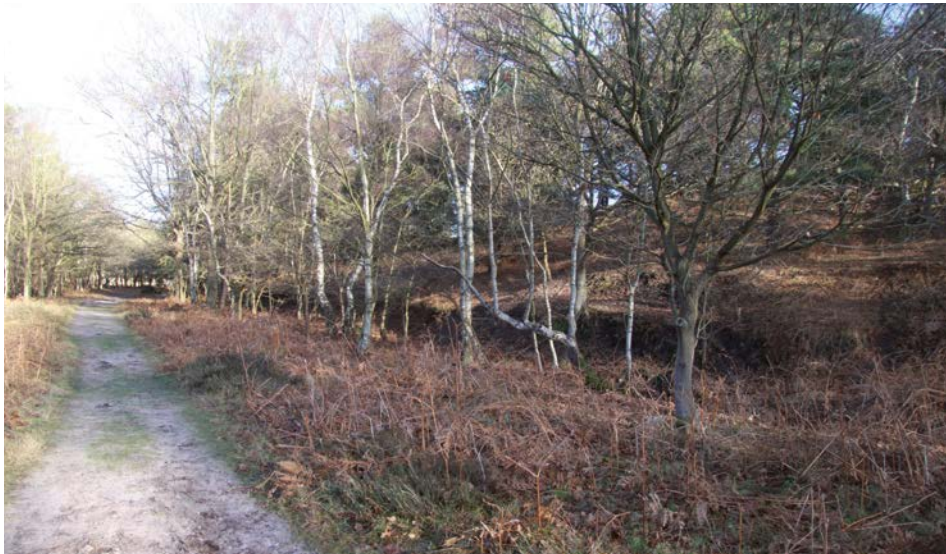
Figure 63. Modern path through the Kruschen ‘Hedgehog’; here the path passes between the anti-tank ditch on one side and the concrete and earthwork defences on the higher ground.

right, the remodelling of the base of the escarpment can be clearly seen and on the ridgeline there are the remains of some of the ‘German’ concrete pillboxes. Some sense of the scale of the practice defences can still be appreciated (Figure 63).

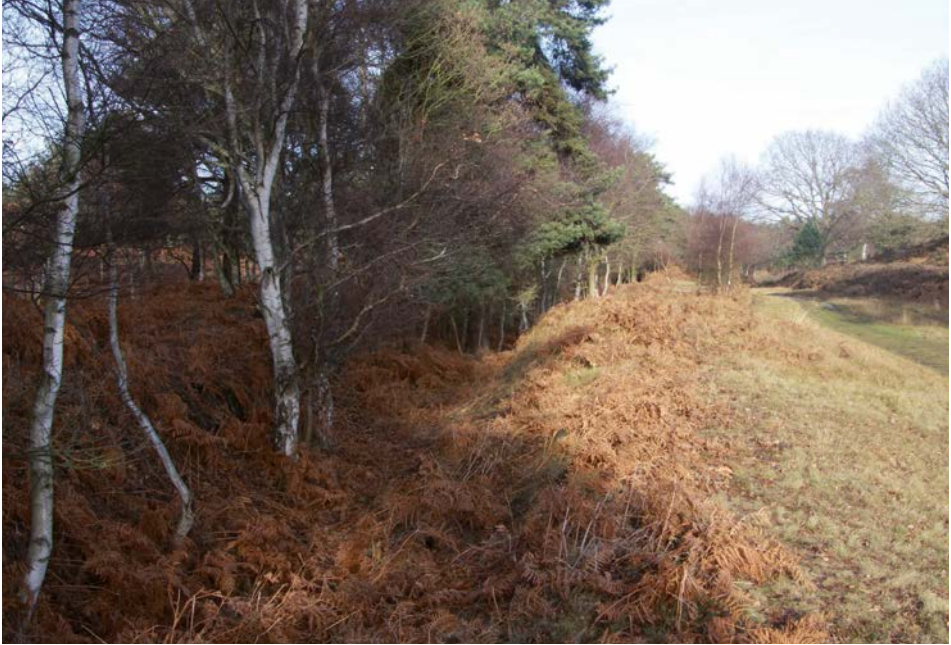
Figure 64. Anti-tank ditch between Westleton Walks and Dunwich Heath. This was excavated in 1941 for anti-invasion defence and protected Dunwich Heath from attack from the west. In 1943 it was re-used to form the eastern side of the Kruschen 'Hedgehog'.

From here, continue along the path which leads away from the hedgehog. At TM 468688 cross via the gate onto Dunwich Heath, which is owned by the National Trust. Walking south soon takes you past a 1941 anti-tank ditch that was re-used in Kruschen in order to form the eastern side of the ‘hedgehog’, Point ‘C’. Today this is still known as the ‘tank trap’, and although it is degraded, it survives well in places (Figure 64). At TM 469681 the terracing that can be seen on the slope is also connected with ‘Kruschen’ and was part of an additional anti-tank obstacle.
