A GUIDE TO SECOND WORLD WAR ARCHAEOLOGY IN SUFFOLK

Guide 2: Walberswick to Aldeburgh

Robert Liddiard and David Sims

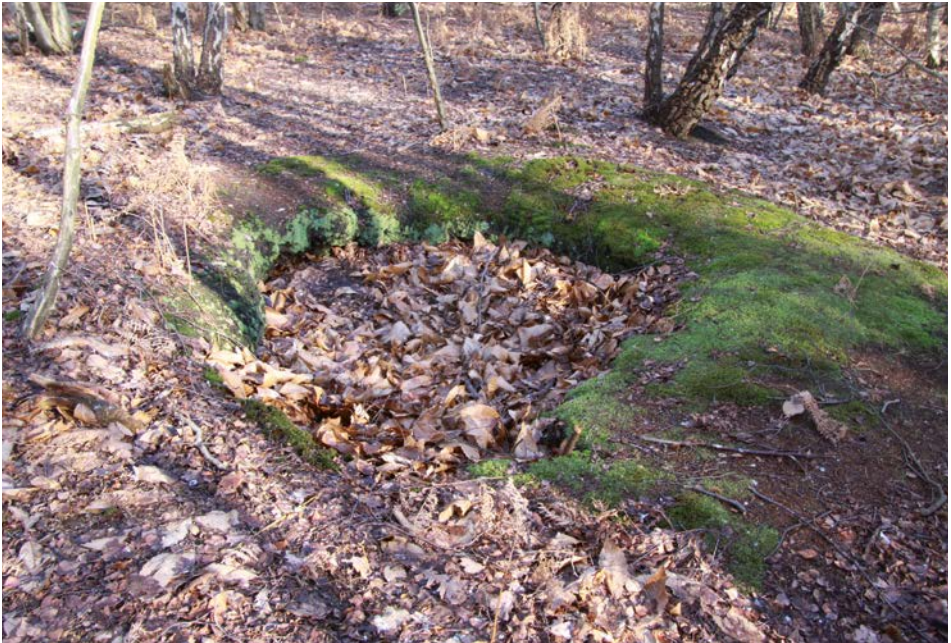
Figure 65. Earthwork remains of keyhole 'Tobruk' stands, built to replicate German machine gun positions.

At this point cross via the gate back onto the RSPB side. At TM 464699 (Point ‘D’) a pair of circular depressions that lie just off the path are the remains of mock German machine gun posts intended to replicate a ‘Tobruk’ shelter, a form of field fortification common in occupied Europe (Figure 65).
